REPORT OF MARINE SURVEY

CONDITION & VALUATION

1994 BAYLINER 4388 MOTORYACHT

Cale Mathers - AMS® #1156
SAMS® Accredited Marine Surveyor®

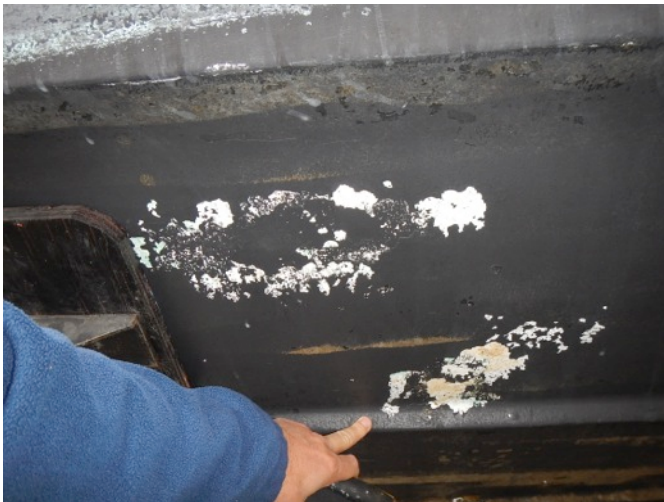
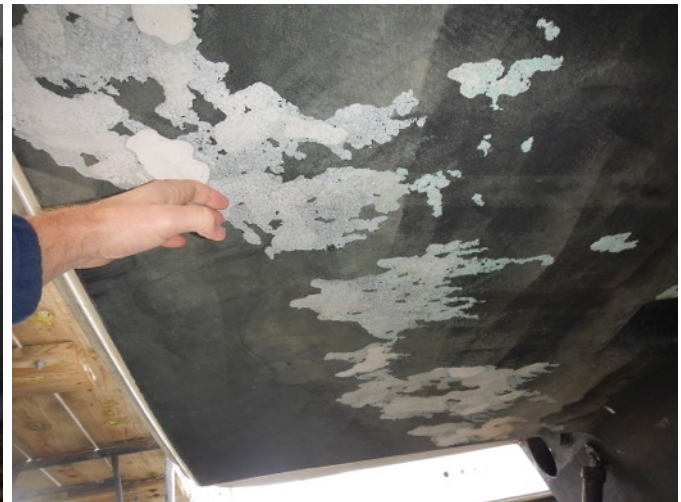
- Vessel's anti-fouling bottom paint was peeling & deteriorating throughout the hull's wetted surface area when sighted at time of out-of-water survey inspection. The bottom paint appears in overall poor / wasted condition. Recommend service & renew vessel's anti-fouling bottom paint as required.

Bottom paint is deteriorating

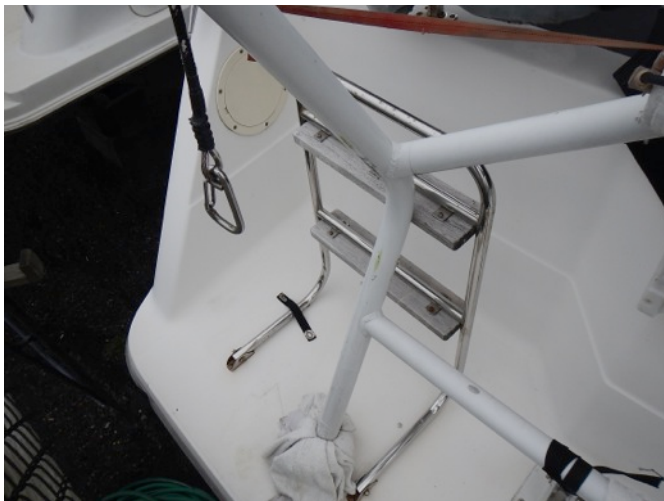
- Vessel's reboarding ladder was inoperable when sighted at time of survey inspection due to its installed location forward of the tender davit structure.
ABYC Standards recommends: Means of unassisted reboarding shall be provided on all boats, and must be accessible to, or deployable by the person in the water (ABYC H-41.9.1).
Recommend equip vessel with reboarding ladder in accordance with ABYC Standards stated above.

Reboarding ladder is obstructed by davit structure

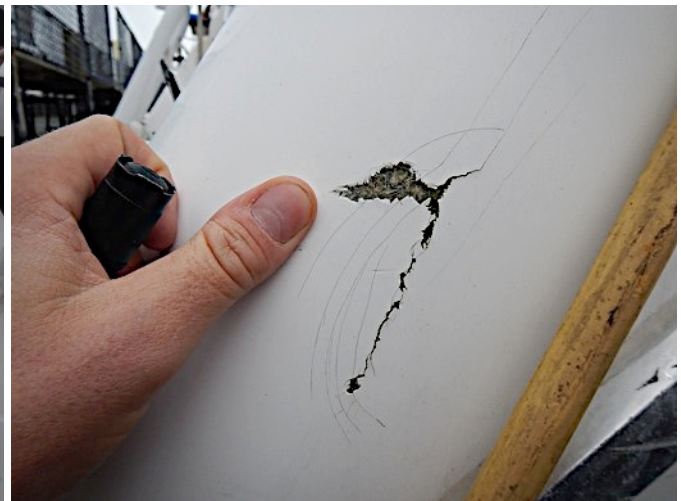
- There was an area of gelcoat & fiberglass damage measuring approx. 6" by 2" sighted at the starboard side of the vessel's transom structure. Damage described is a serviceable deficiency. Recommend monitor the condition of the fiberglass damage described, and service / repair as required.

Gelcoat & fiberglass damage

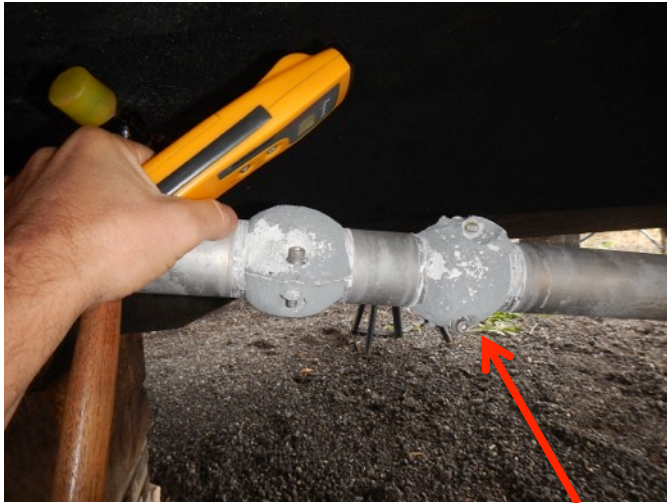
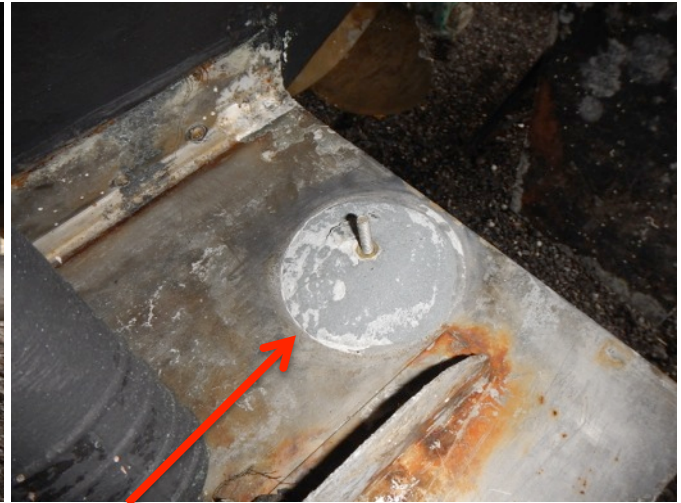
- The sacrificial zinc anodes installed at the trim tabs & prop shafts were deteriorated and appeared near the end of their useful lives when sighted at time of survey inspection. The zinc anode plates installed at studs fastened to the hull's transom structure were new / excellent. Recommend monitor the condition of the vessel's sacrificial zinc anodes on a semi-annual basis, and renew zincs as required.

Zinc anodes are deteriorating

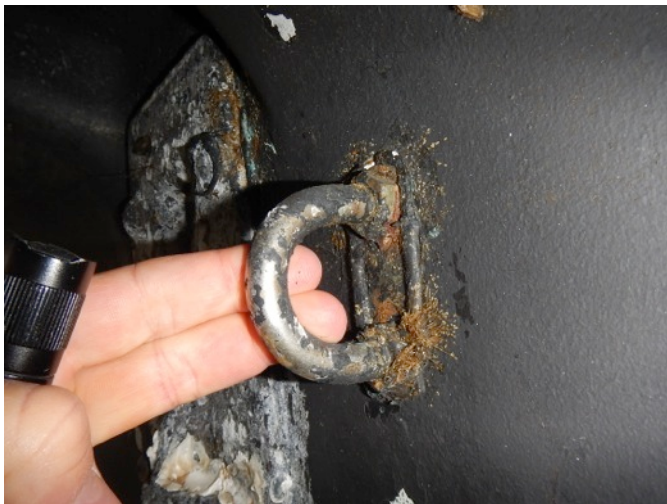
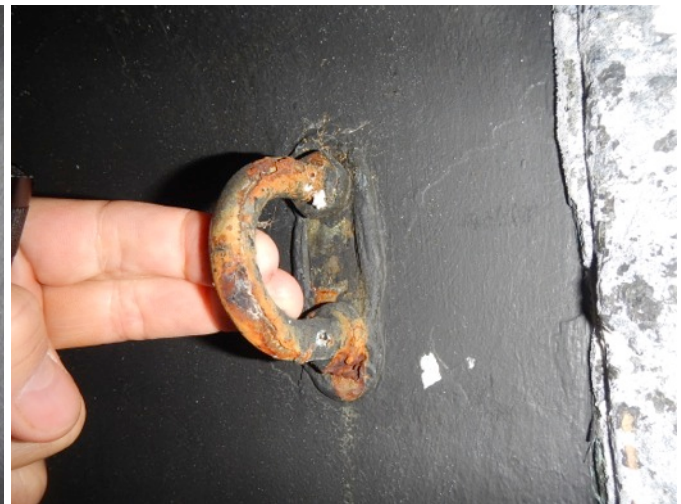
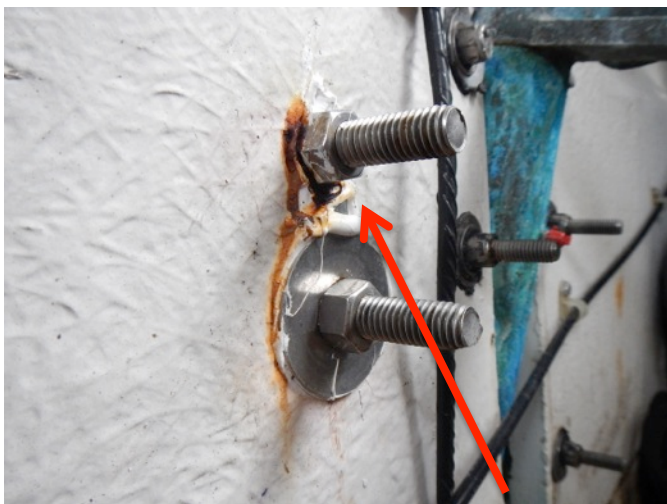
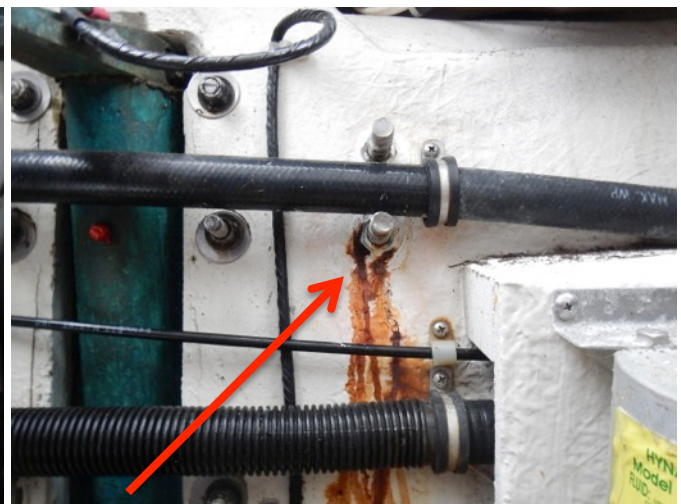
- There was evidence of crevice corrosion & water intrusion identified at the two stainless steel U-bolt fittings fastened to the vessel's transom structure when sighted at time of survey inspection. Monitor the fittings described to determine the severity of fasteners deterioration & rate of water intrusion. Recommend either renew & rebed U-bolt fittings, or remove fittings & seal holes in the transom structure at time of vessel's next out-of-water service.

Water intrusion & crevice corrosion at U-bolt fittings

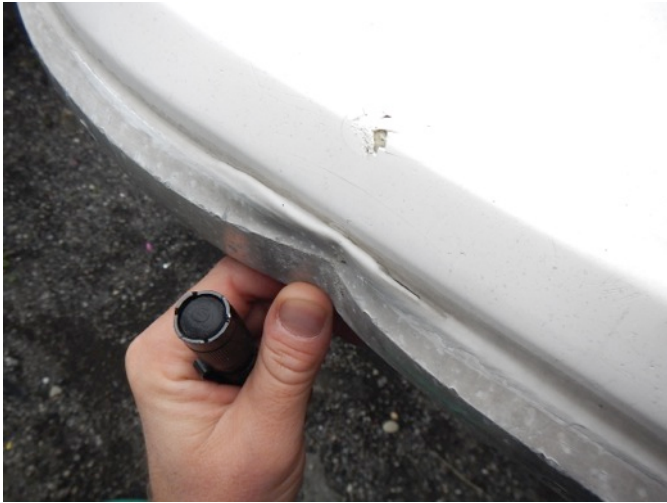
- There was a dent identified in the vessel's aluminum rub rail structure at the port side of the swim step perimeter when sighted at time of survey inspection. Damage described is a cosmetic deficiency. Recommend monitor the condition of the rub rail at the damaged area described, and service / repair as required.

Dent in aluminum rub rail

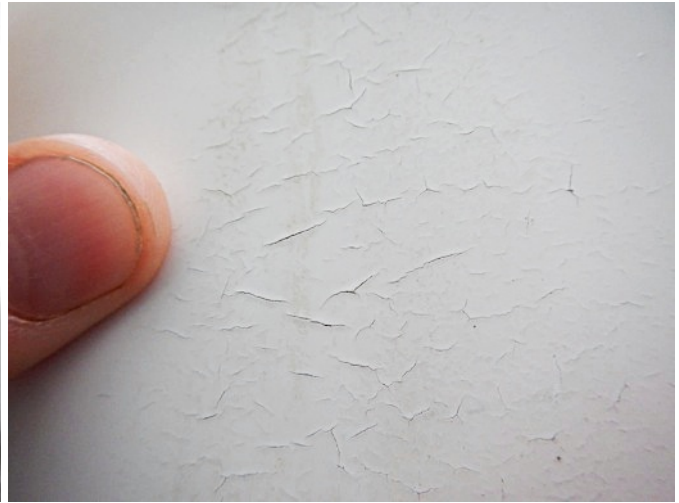
- There was minor gelcoat cracking sighted in various places at the vessel's hull topsides structures when sighted at time of survey inspection. All gelcoat damage sighted is a serviceable cosmetic deficiency. Recommend monitor areas of gelcoat cracking described, and service / repair as required.

Gelcoat crazing

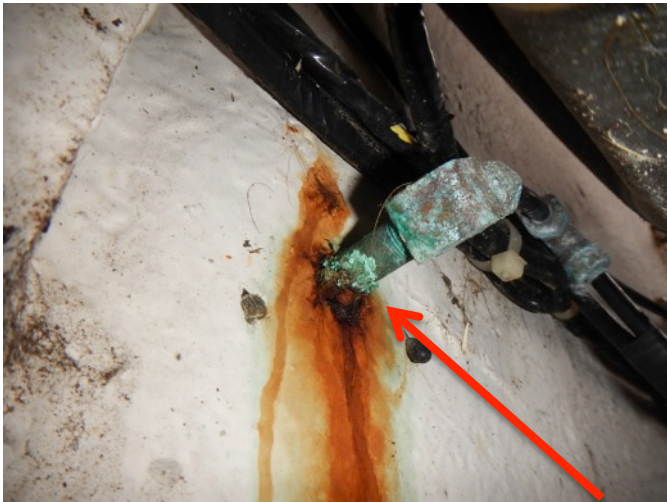
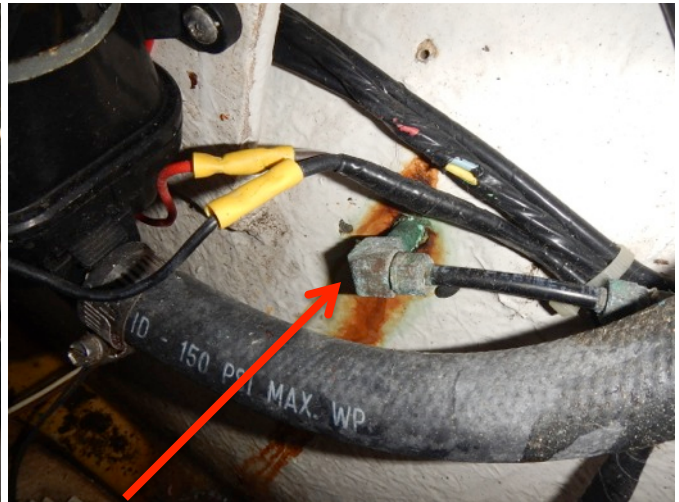
- There was evidence of crevice corrosion & water intrusion sighted at several trim tab cylinder fasteners secured to the vessel's transom structure when sighted at time of survey inspection. Recommend monitor the trim tab fasteners described to determine the severity of fasteners deterioration & rate of water intrusion, renew trim tab cylinder fasteners & rebed cylinders to transom structure with marine adhesive sealant as required.

Water intrusion & crevice corrosion at trim tab cylinder fasteners

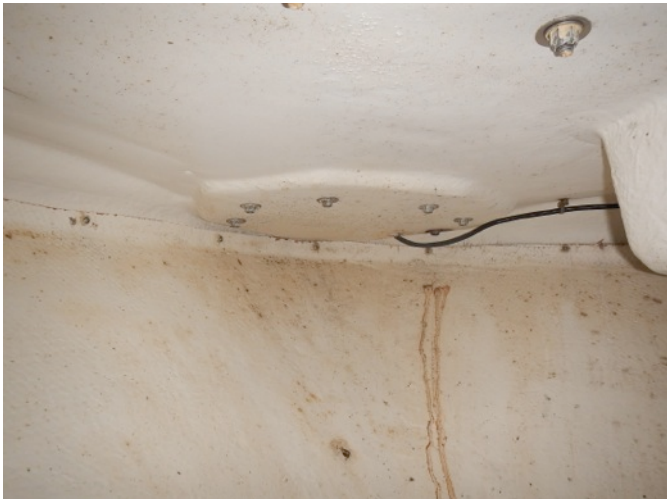
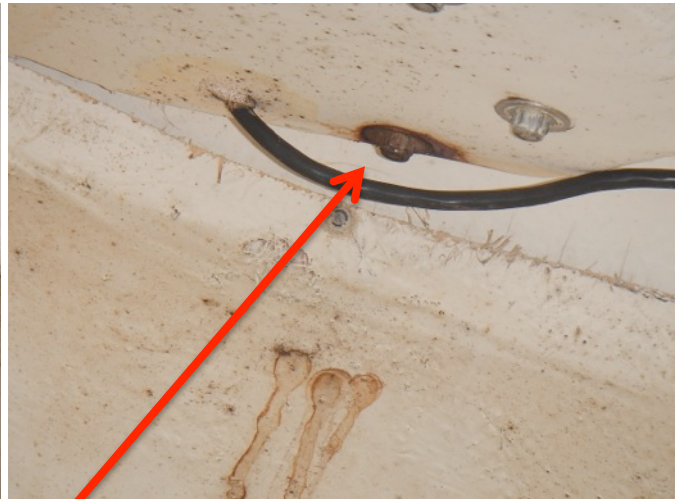
- There was a water leak identified at one of the fasteners used to secure the bow pulpit structure to the foredeck as sighted from chain locker interior at time of survey inspection. Water intrusion deficiency described can potentially result in the foredeck core material becoming saturated with water, which leads to deterioration. Recommend remove & renew leaking fastener described. Inspect foredeck core material when fastener is removed. Rebed fastener with marine adhesive sealant. Service / repair damaged foredeck core material as required.

Water intrusion at pulpit structure fastener

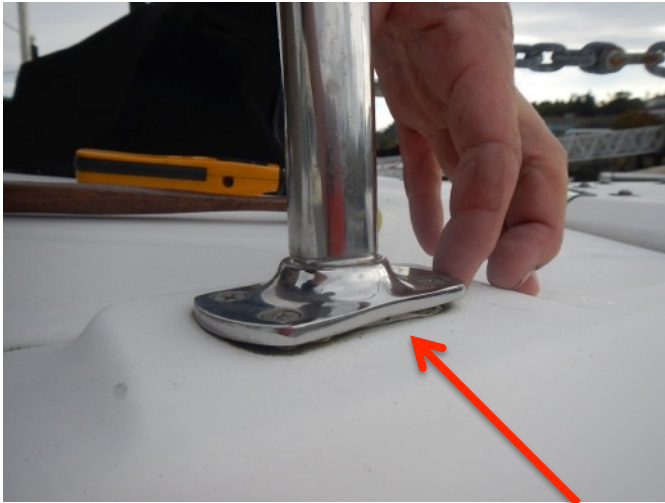
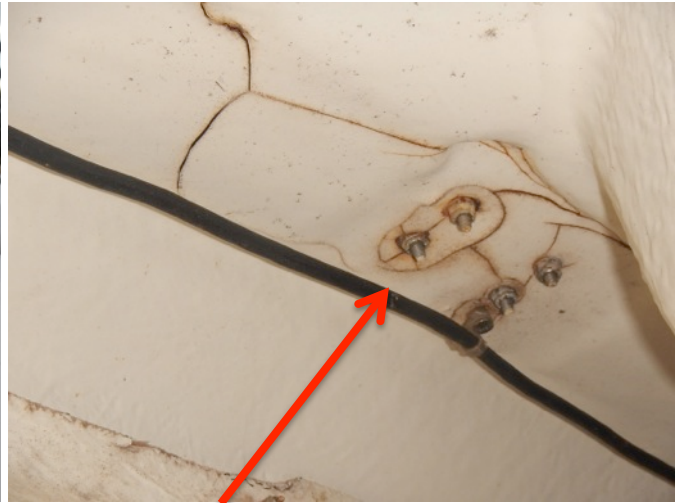
- One of the bow rail stanchion bases at the starboard side foredeck structure was bent & loose when sighted at time of survey inspection. The fiberglass structure surrounding the stanchion base fasteners at the chain locker interior was damaged. There was evidence of water intrusion at the damaged stanchion base fasteners described. Recommend rebed & resecure the damaged bow rail stanchion base described. Recommend install and oversized fastener backing plate at the chain locker interior location to strengthen the damaged fiberglass.

Bow rail stanchion base is loose. Fiberglass is damaged at stanchion base fasteners

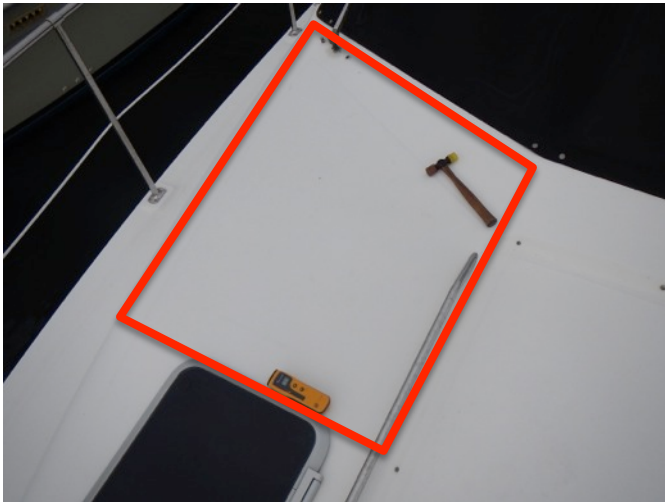
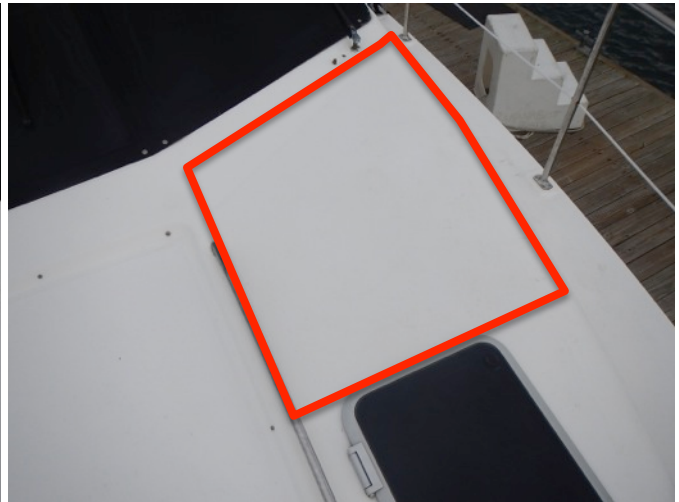
- There were two large areas of soft foredeck structure identified forward of the port & starboard windshield frames when tested at time of survey inspection. Percussion hammer soundings were dull, moisture meter readings were extremely elevated, and the deck structure was physically soft when a minimal amount of pressure was applied to the areas described. Recommend consult with a reputable boatyard for foredeck service options, and service / repair soft foredeck areas described as required.

Soft foredeck structure

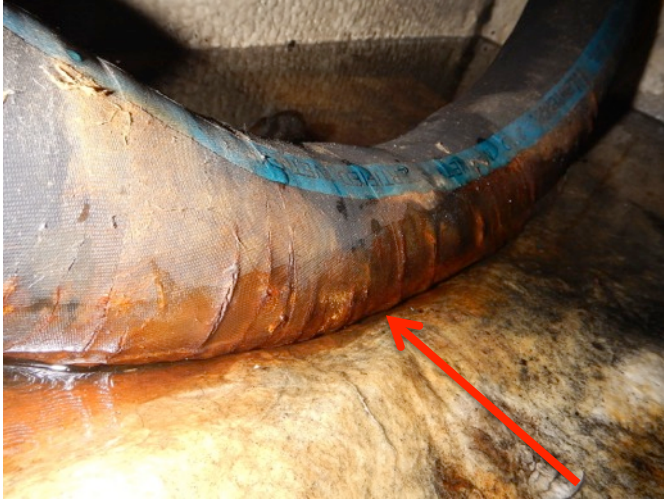
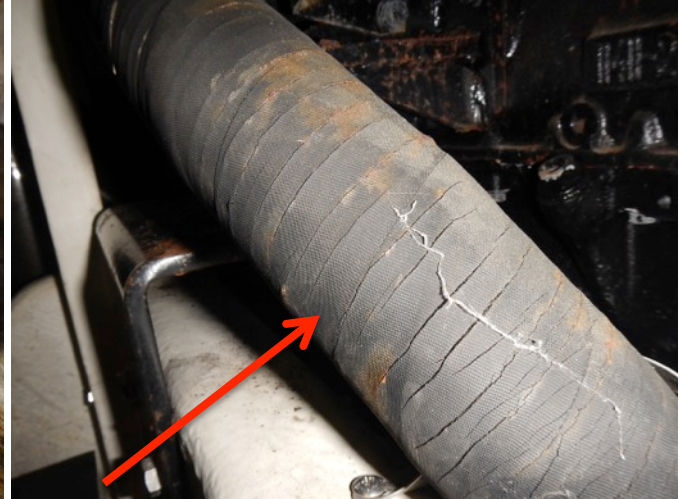
Main engine seawater intake hoses are cracking

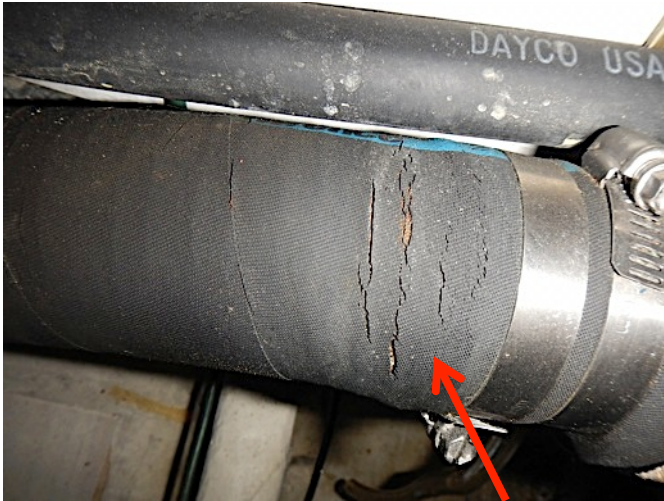
Main engine seawater intake hoses are cracking

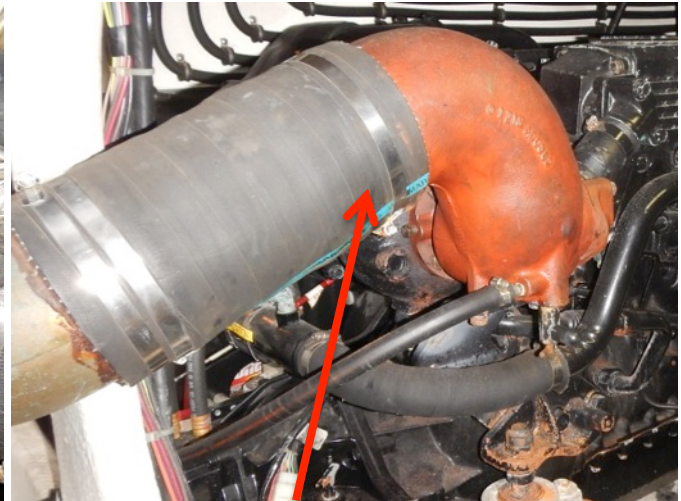
- This report does not represent a full mechanical / engine survey inspection. For more detailed information pertaining to the working condition of engine components it is recommended a certified marine technician perform a detailed mechanical inspection.
- The port & starboard main engine seawater intake hose sections between the sea strainers & engine seawater pumps were cracking & deteriorating and in overall poor / wasted condition when sighted at time of survey inspection. Recommend renew main engine seawater intake hoses described.
- The port engine exhaust hose connection to the exhaust elbow was secured with a single hose clamp fastener when sighted at time of survey inspection.

ABYC Standards recommends: *Every exhaust hose connection shall be secured with at least two non-overlapping clamps at each end to produce a secure, liquid and vapor-tight joint (ABYC P-1.7.1.10.1).*

Single hose clamp fastener at main engine exhaust hose

Recommend install additional marine grade stainless steel hose clamp fasteners at port engine exhaust hose connection described in accordance with ABYC Standards stated above.

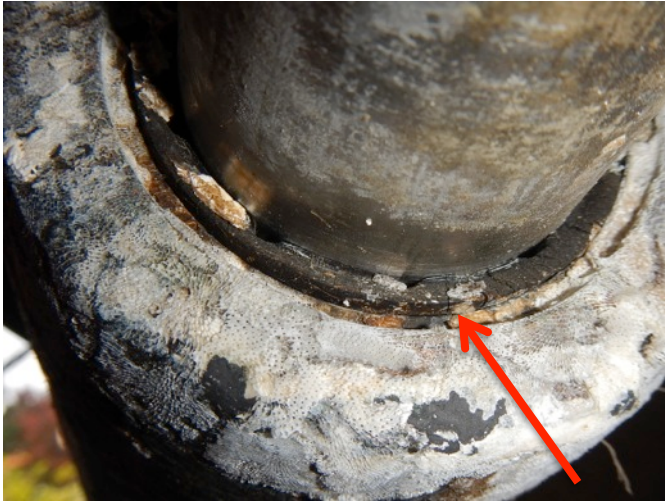
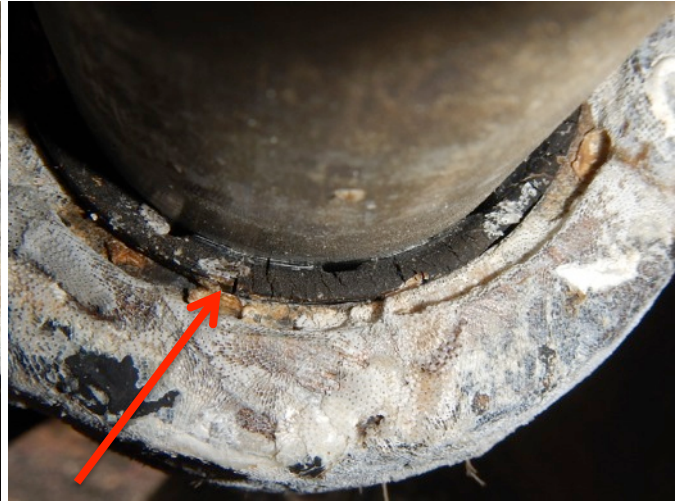
- The vessel's cutlass bearings were in overall poor / wasted condition when sighted at time of out-of-water inspection. The rubber portion of the cutlass bearings have become separated from the bronze sleeve, and were sighted spinning with the prop shafts when the props were rotated. Recommend renew vessel's cutlass bearings.
- The starboard engine stuffing box shaft seal was leaking seawater excessively when sighted at time of survey inspection. There was a constant stream of seawater leaking into the vessel's bilge from the shaft seal while vessel lay afloat during inspection. Recommend either service / adjust shaft seal described to eliminate excessive seawater leakage, or repack stuffing box with new packing gland as required. Monitor both port & starboard shaft seals for recurring deficiency, and service as required.

Cutlass bearings are in need of renewal

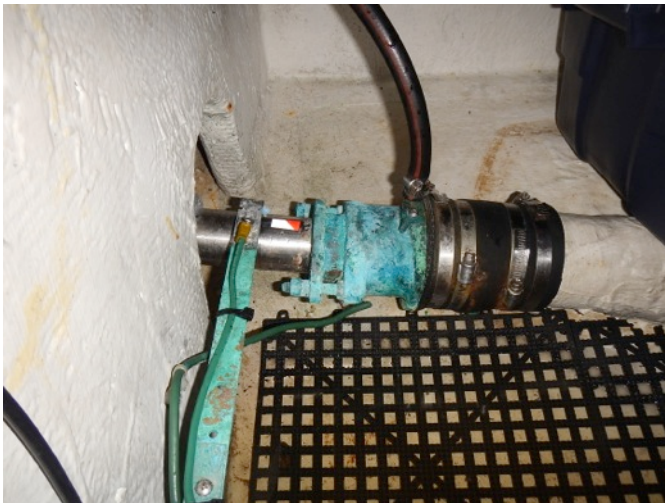
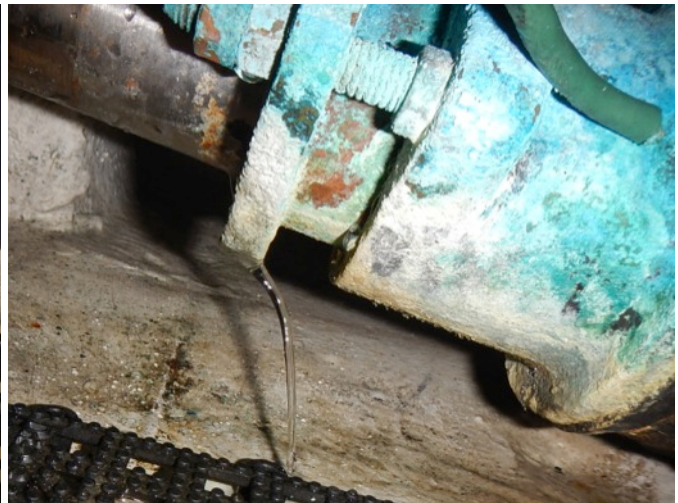
Starboard engine shaft seal leaking excessively

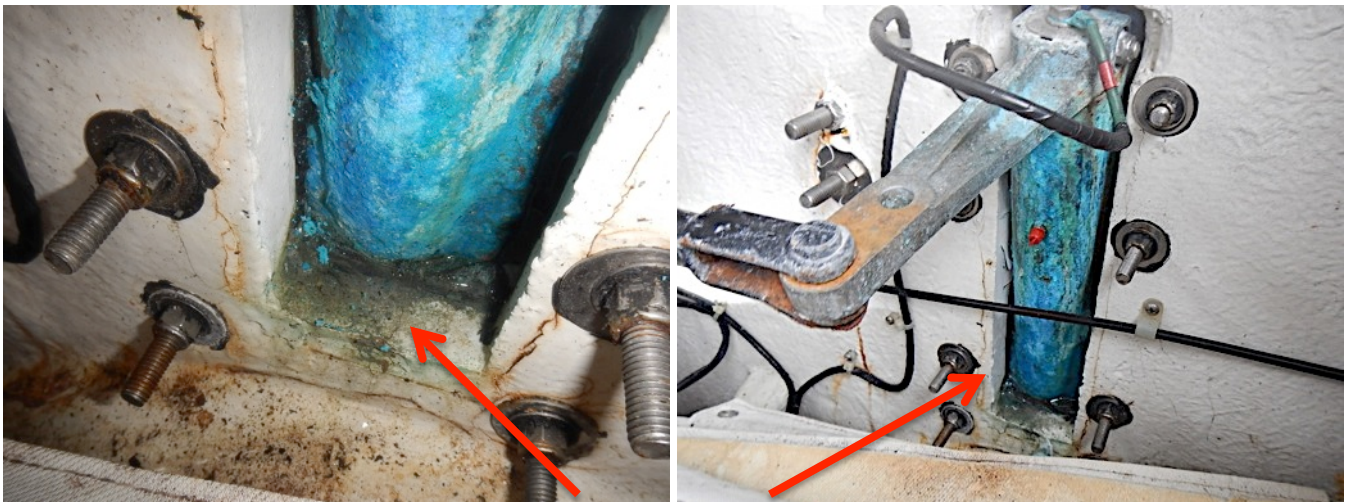
- There was water intrusion identified at the port & starboard rudder systems when sighted at time of survey inspection. Rudder system used is a transom mounted rudder assembly with marine adhesive sealant applied to the perimeter of the assembly to prevent water intrusion through the transom rudder cutouts. It appears that the sealant has deteriorated, allowing seawater to weep through the transom cutouts and into the lazarette bilge. Recommend remove rudder assemblies from vessel's transom structure, and reinstall with new fasteners & new marine adhesive sealant.

Water leak at rudder assembly to transom seal

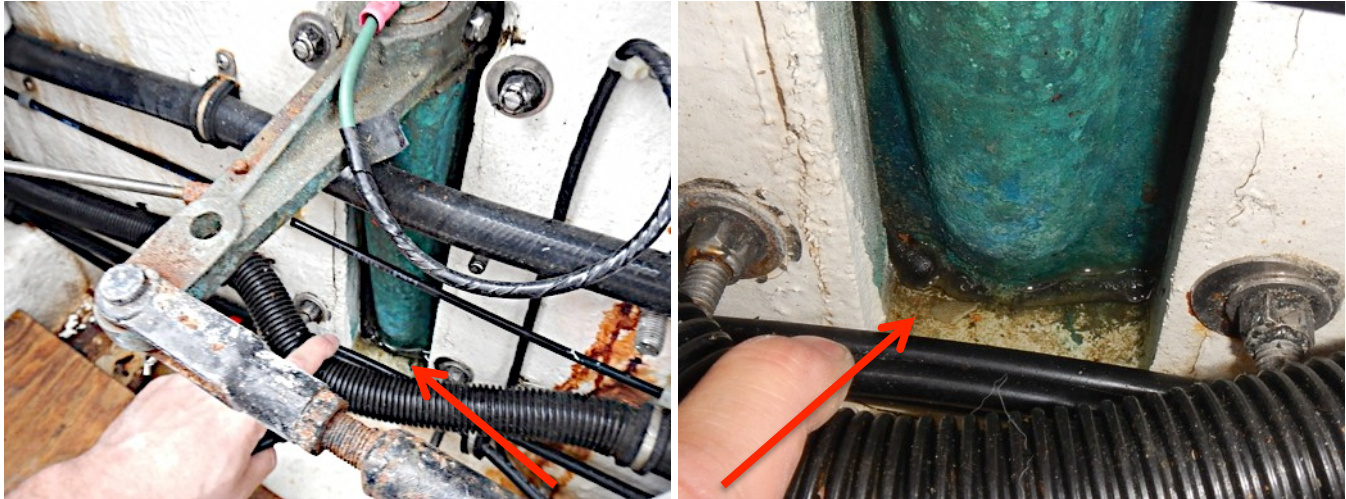
Water leak at rudder assembly to transom seal

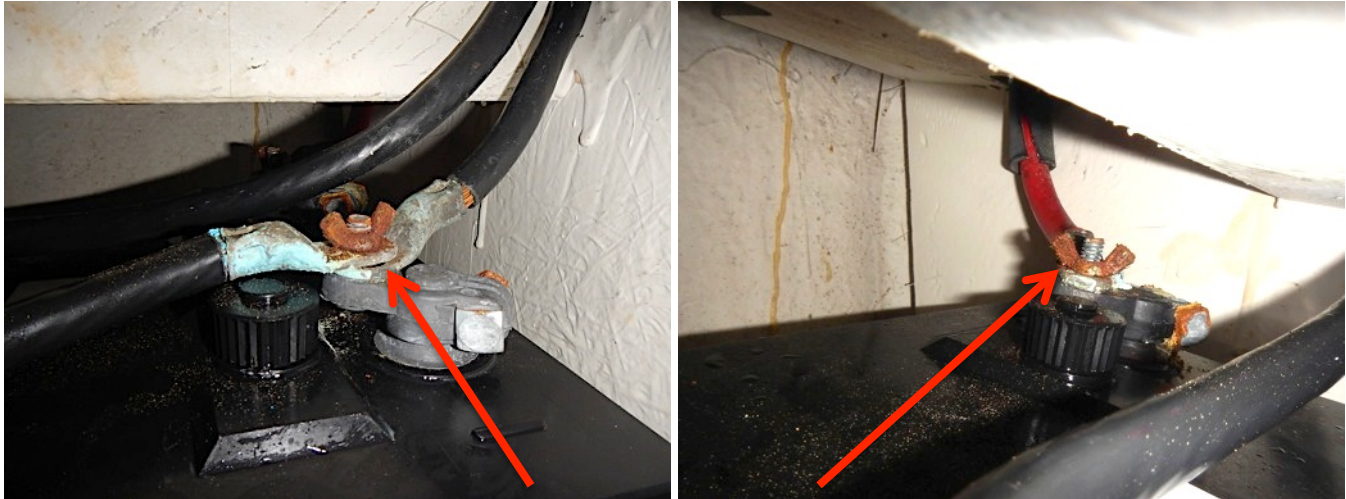
- The vessel's DC power system Start Bank battery uses wing nut fasteners to secure conductors to battery terminals. Wing nut fasteners have the tendency to vibrate loose and result in poor connections. The wing nuts fasteners were corroded when sighted at time of survey inspection.

ABYC Standards recommends: *Battery cables and other conductors size 6 AWG and larger shall not be connected to the battery with wing nuts (ABYC E-10.8.3).*

Wing nut fasteners & corrosion at battery terminals

Recommend renew wing nut fasteners at battery terminals with marine grade stainless steel hex nut style fasteners.

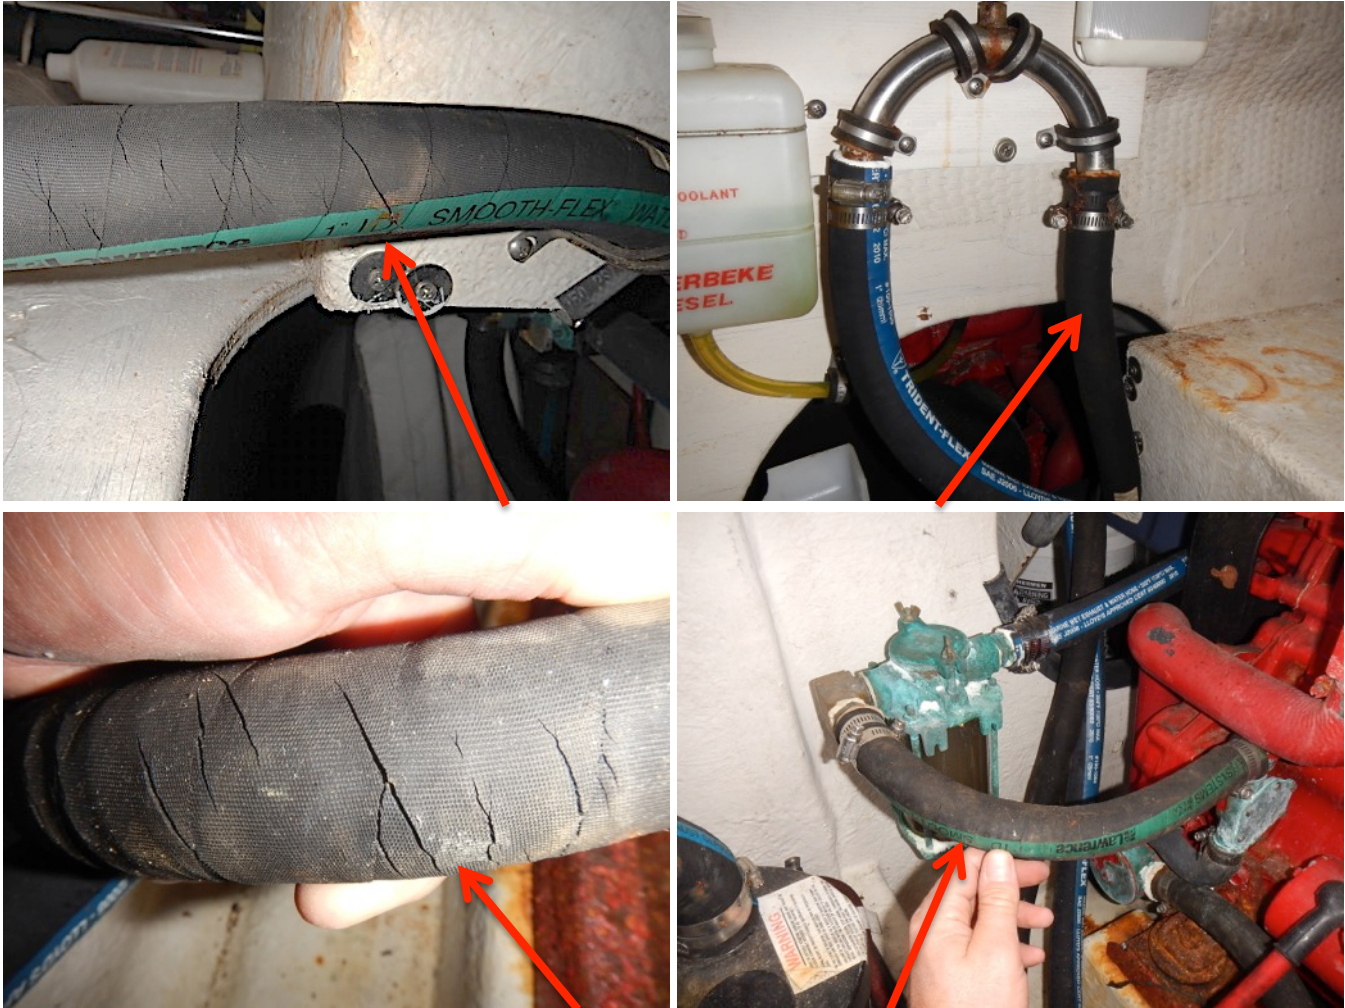
- The majority of the generator engine seawater cooling system hoses were cracking, and appeared in overall poor / deteriorating condition. Recommend renew all cracking generator engine seawater cooling system hoses.
- All sections of generator engine exhaust hose was cracking, and appeared in poor / deteriorating condition when sighted at time of survey inspection. Recommend renew all generator engine exhaust hose.
- There was corrosion sighted at the cap ends of the generator engine heat exchanger when sighted at time of survey inspection. Heat exchanger requires disassembly for closer inspection. Overall condition is undetermined. Recommend monitor the condition of the generator engine heat exchanger, and service or renew heat exchanger components as required.

Generator seawater cooling system hoses are cracking

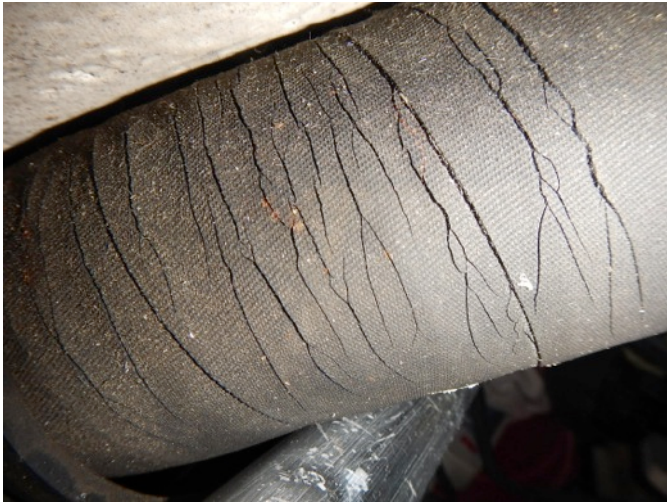
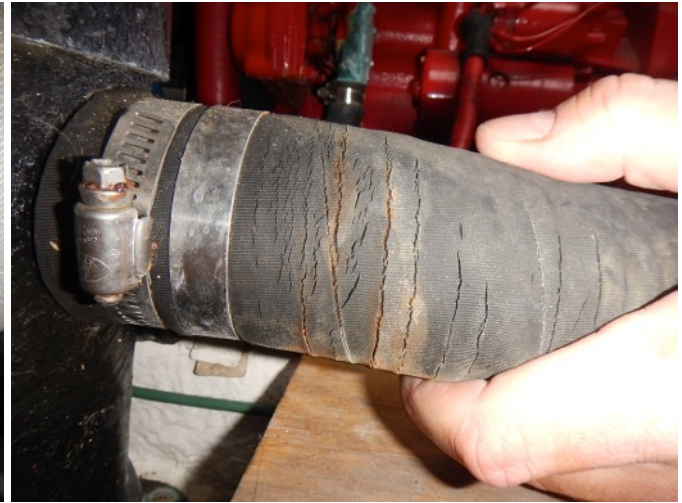
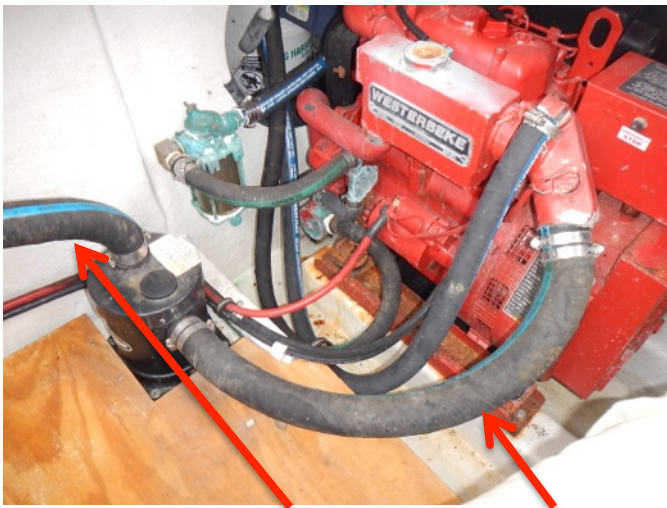
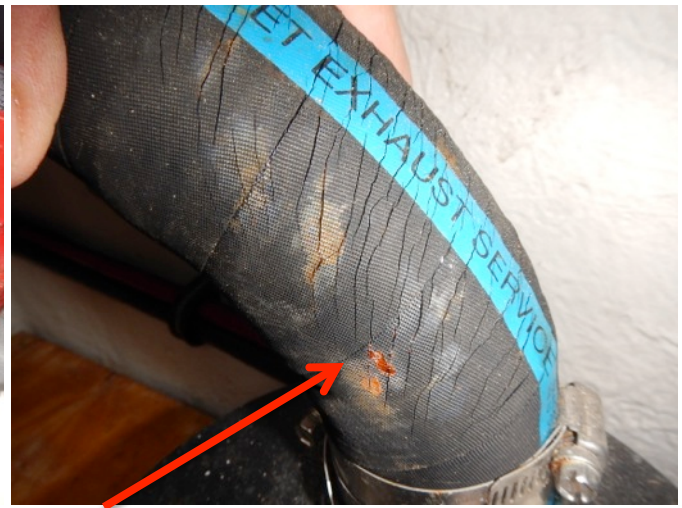
Generator exhaust hoses are cracking

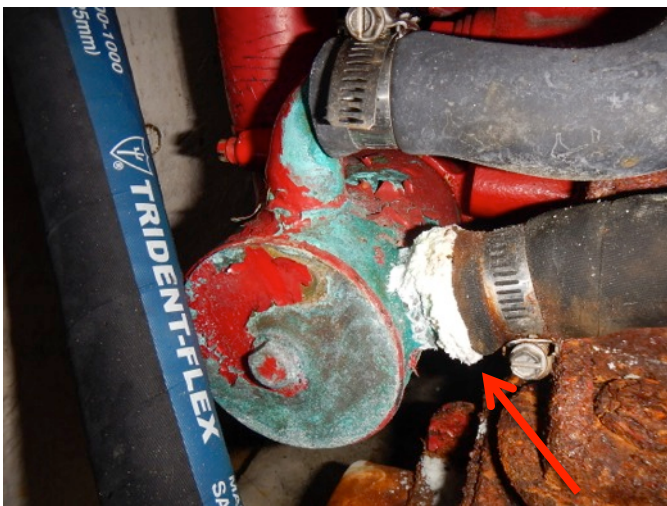
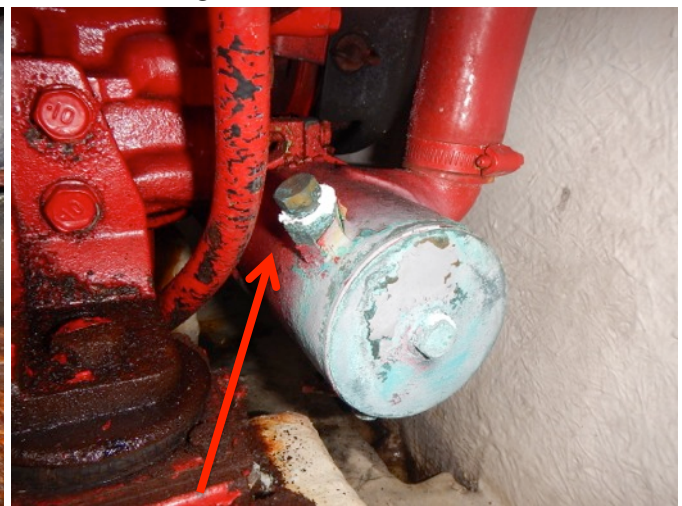
End caps of generator heat exchanger are corroded

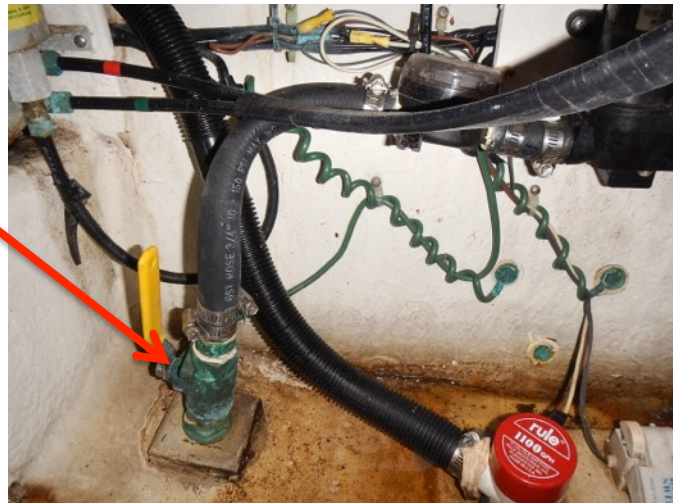
- The below-the-waterline thru-hull ball valve seacock used for seawater intake to the washdown pump system was stiff & difficult to operate when tested at time of survey inspection. Recommend service / lubricate & exercise seacock valve described so that all seacock valves are functional by hand, without the use of tools.

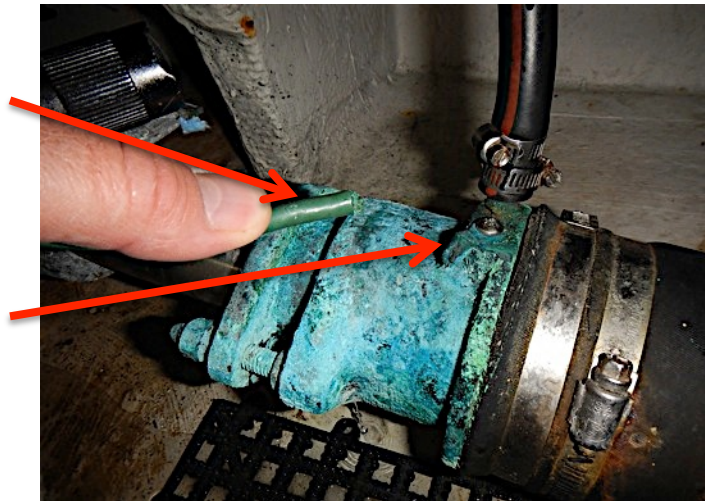
- The bonding / DC grounding system conductor used to terminate the starboard engine stuffing box shaft seal was broken / connection severed when sighted at time of survey inspection. Recommend renew the bonding conductor ring connector end, and re-terminate the broken bonding conductor described to the starboard engine shaft seal.

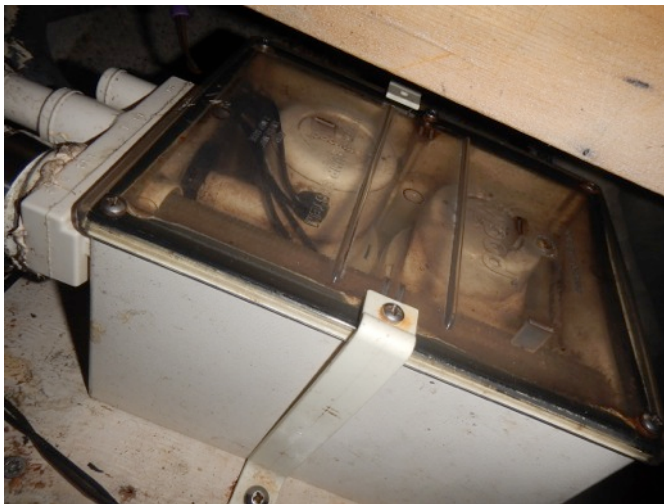
- The seawater washdown pump system was inoperable / would not power on when tested at time of survey inspection. Source of deficiency is undetermined and requires further troubleshooting. Recommend service / repair or renew components of the seawater washdown system as required.
- The shower sump pump was inoperable / would not power on when tested at time of survey inspection. Source of deficiency is undetermined and requires further troubleshooting. Recommend service / repair or renew components of the shower sump pump system as required.

Shower sump pump is inoperable

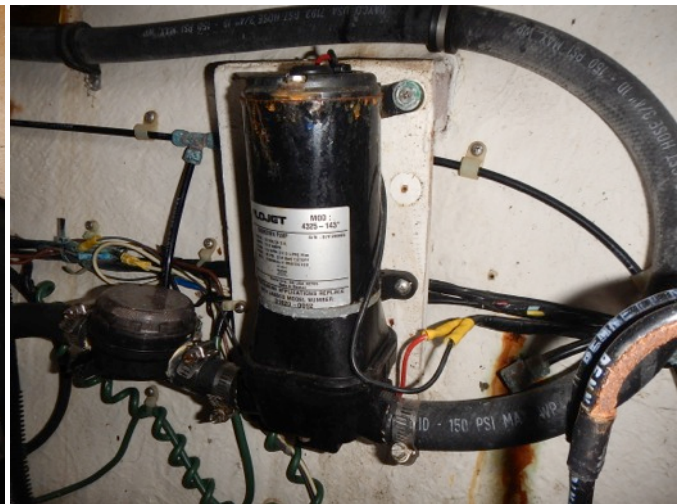
Raw water washdown pump is inoperable

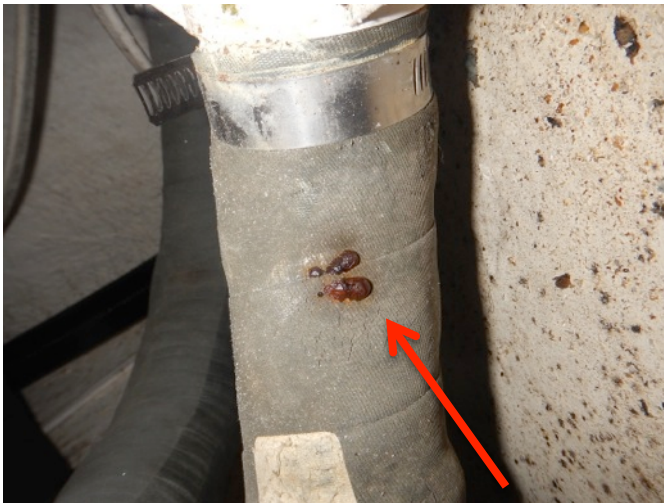
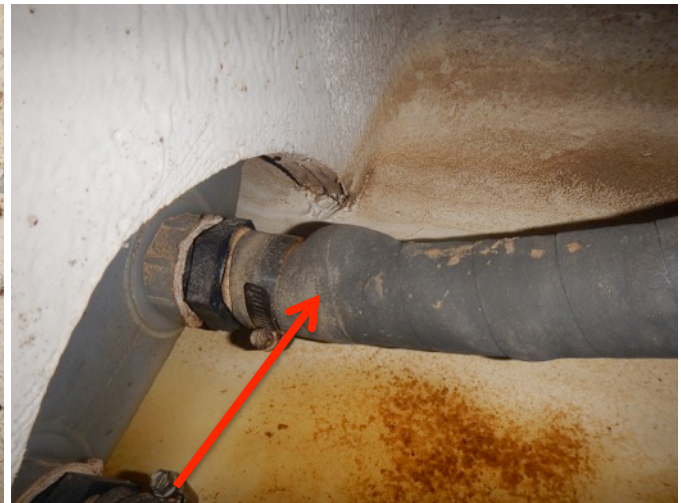
- The vessel's rubber sanitation system hoses were bulging in several places with a small sanitation leak identified at one location when sighted at time of survey inspection. Sanitation system hoses appear in overall poor / deteriorating condition. Recommend monitor the condition of the vessel's rubber sanitation system hoses, and renew hoses as require.

Sanitation system hoses are bulging & leaking

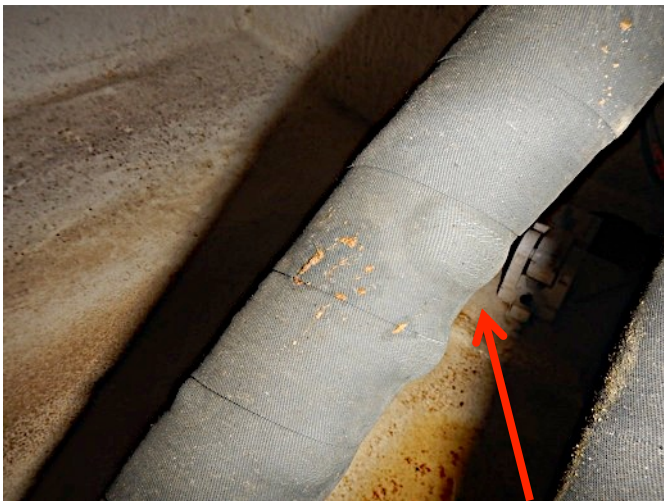
Sanitation system hoses are bulging

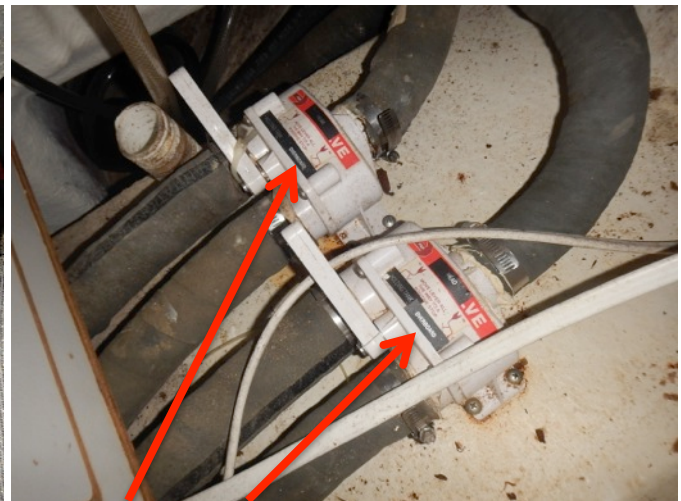
- The two sanitation system Y-valves used to bypass the black water holding tank and flush the marine toilets directly overboard were inoperable when tested at time of survey inspection. The Y-valves are currently set to flush the toilets into the black water holding tank. The Y-valves do not need to be operational for the vessel's sanitation system to operate properly. It is illegal to flush black water waste directly overboard in the Puget Sound region. If the black water direct overboard discharge option is desired, it appears that the vessel's sanitation system Y-valves require renewal.

Sanitation system Y-valves are inoperable

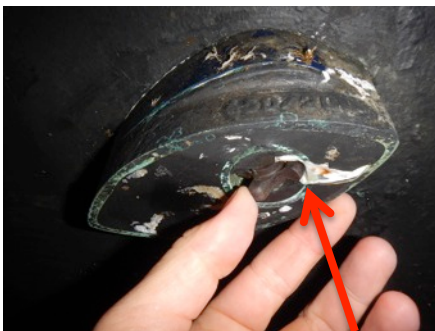
- The speed-over-water paddle wheel installed at the thru-hull transducer was inoperable due to marine growth blockage when sighted at time of haul-out inspection. Recommend service / clean blockage described at paddle wheel as required to make speed-over-water gauge operational.

Paddle wheel is inoperable

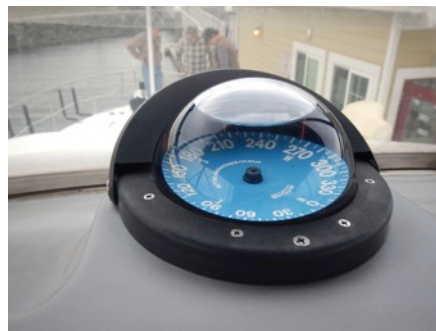
- There was an air bubble in the compass dome of the magnetic compass at the flybridge pilot station when sighted at time of survey inspection. If the air bubble becomes large, the compass will no longer function accurately. Recommend monitor the size of the air bubble inside the compass dome described, and service or renew compass if condition worsens.

Air bubble in compass dome

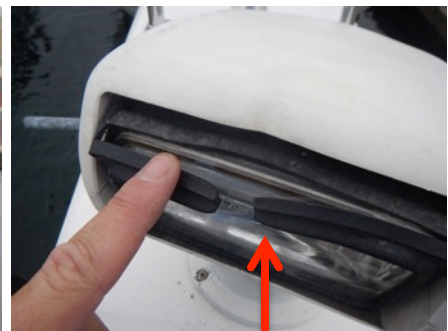
- The foredeck searchlight system was inoperable / would not power on when tested at time of survey inspection. Plastic searchlight components were identified as damaged when system was inspected. Recommend service / repair or renew searchlight components as required.

Search light is damaged

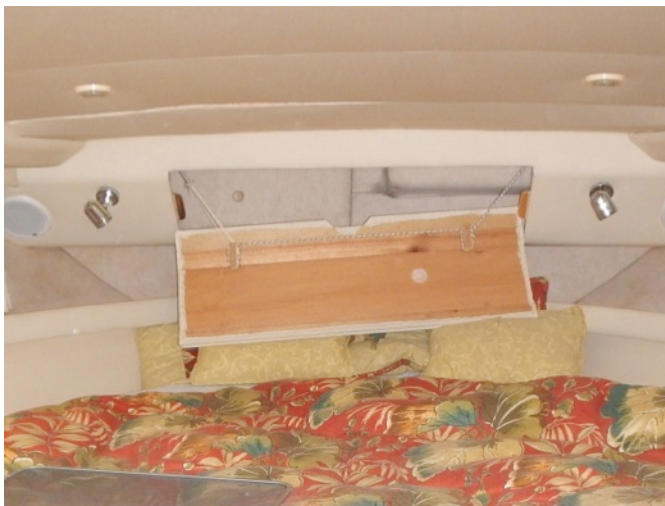
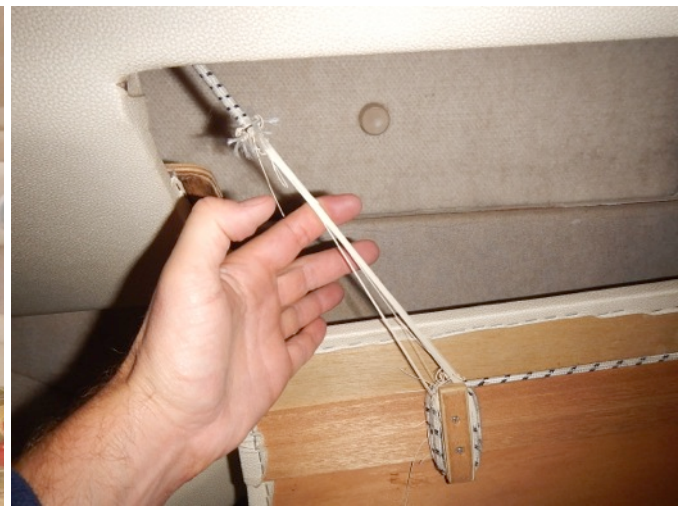
- The chain locker access panel at the V-berth interior would not maintain in the closed position when tested at time of survey inspection. The bungee cord used to secure the access panel closed was weak & deteriorating. Recommend service / repair the inoperable chain locker access panel described as required.

Chain locker access panel requires service
