REPORT OF MARINE SURVEY

CONDITION & VALUATION

1994 BAYLINER 4388 MOTORYACHT

Cale Mathers - AMS® #1156
SAMS® Accredited Marine Surveyor®

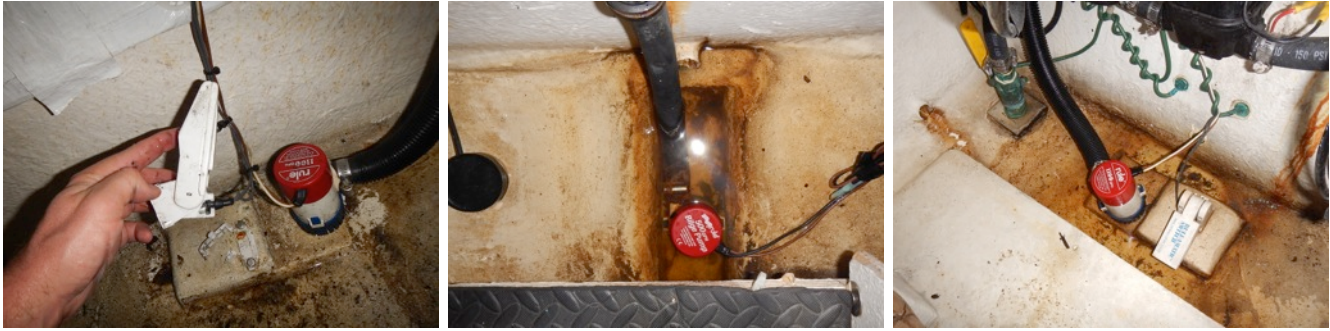
- Three of the four bilge pumps installed onboard the vessel were not functioning properly when tested at time of survey inspection. The forward most bilge pump was fully operational, powering on with both manual switch & automatic float switch. The bilge pump installed at the forward bulkhead of the engine compartment powered on with the manual switch, however, the automatic float switch function of the pump was inoperable. The bilge pumps at the aft engine compartment location & the lazarette location were inoperable / would not power on when tested. Recommend either service / repair or renew components of inoperable bilge pump systems described as required.

Inoperable bilge pump systems

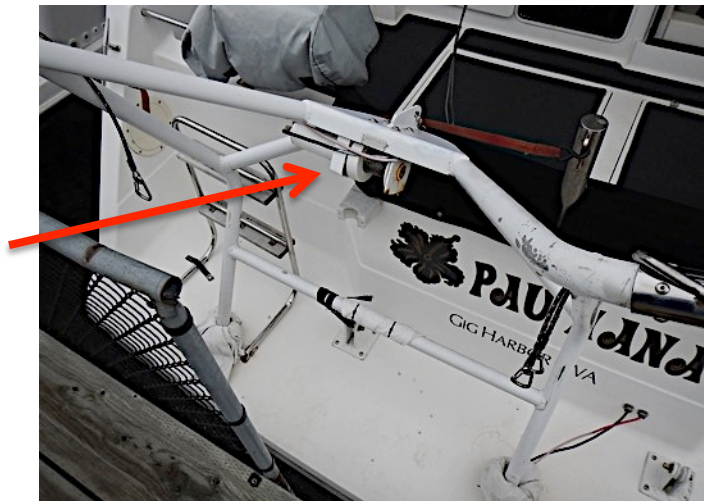
- The swim step mounted tender davit winch powered on in the OUT direction when tested at time of survey inspection, however, the winch was inoperable in the IN direction. Source of deficiency is undetermined and requires further troubleshooting. Recommend service / repair or renew components of the davit winch control system as required.
