REPORT OF MARINE SURVEY

CONDITION & VALUATION

2007 GRAND BANKS 49 EASTBAY SX

M/V “[REDACTED]”

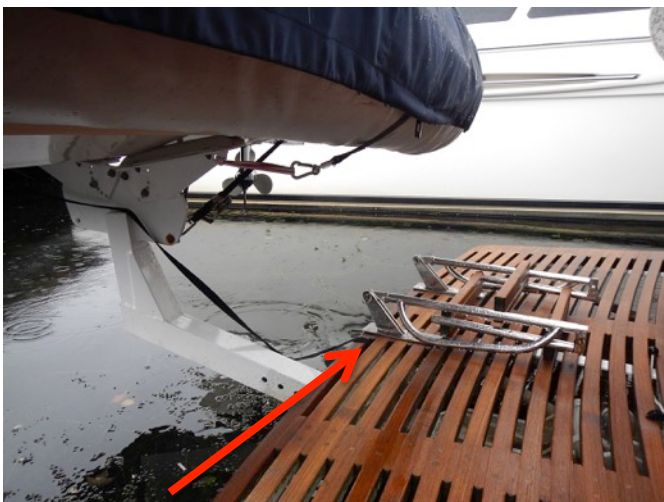
- The vessel's reboarding ladder system, mounted to the swim step structure, is inoperable / obstructed when the RIB tender is mounted on the Freedom Lift davit system at the vessel's stern.
ABYC Standards recommends: *Means of unassisted reboarding shall be provided on all boats, and must be accessible to, or deployable by the person in the water (ABYC H-41.9.1).*
Recommend reconfigure vessel's reboarding ladder system in accordance with ABYC Standards stated above.

Reboarding ladder system is obstructed by the tender

1. The vessel's reboarding ladder system, mounted to the swim step structure, is inoperable / obstructed when the RIB tender is mounted on the Freedom Lift davit system at the vessel's stern.
ABYC Standards recommends: *Means of unassisted reboarding shall be provided on all boats, and must be accessible to, or deployable by the person in the water (ABYC H-41.9.1).*
Recommend reconfigure vessel's reboarding ladder system in accordance with ABYC Standards stated above.

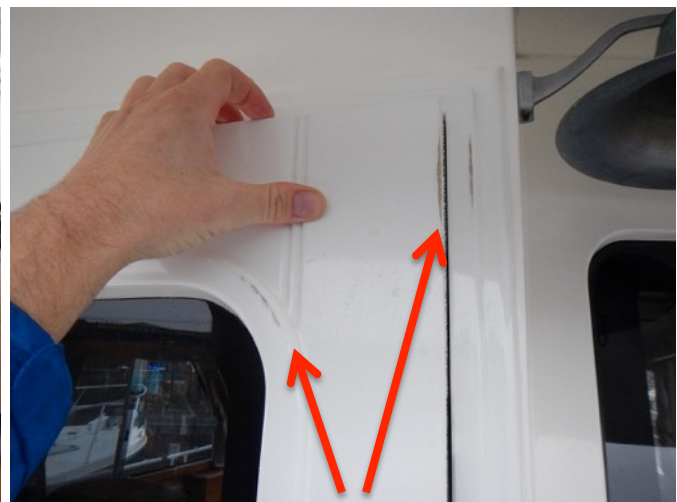
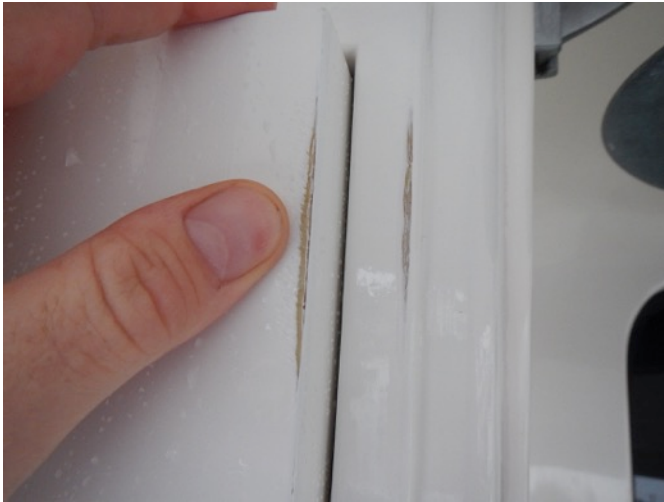
- There were minor cosmetic gelcoat deficiencies identified at the vessel's deck structure & superstructure when sighted at time of survey inspection. Deficiencies described include: gelcoat scratching at the salon door frame, gelcoat crack at the non-skid area of the port-side foredeck structure, gelcoat stress cracking at the underside of the chain locker deck-hatch structures, gelcoat cracking at the exterior frames of the pilothouse windshield structures, and a gelcoat chip in the starboard-side salon area superstructure resulting from an air-bubble void left during the manufacturing process. All gelcoat deficiencies described are serviceable. Recommend monitor the condition of the gelcoat damage described, and service / repair as required (see pictures below).

Gelcoat scratching at salon doorframe

1. There were minor cosmetic gelcoat deficiencies identified at the vessel's deck structure & superstructure when sighted at time of survey inspection. Deficiencies described include: gelcoat scratching at the salon door frame, gelcoat crack at the non-skid area of the port-side foredeck structure, gelcoat stress cracking at the underside of the chain locker deck-hatch structures, gelcoat cracking at the exterior frames of the pilothouse windshield structures, and a gelcoat chip in the starboard-side salon area superstructure resulting from an air-bubble void left during the manufacturing process. All gelcoat deficiencies described are serviceable. Recommend monitor the condition of the gelcoat damage described, and service / repair as required.

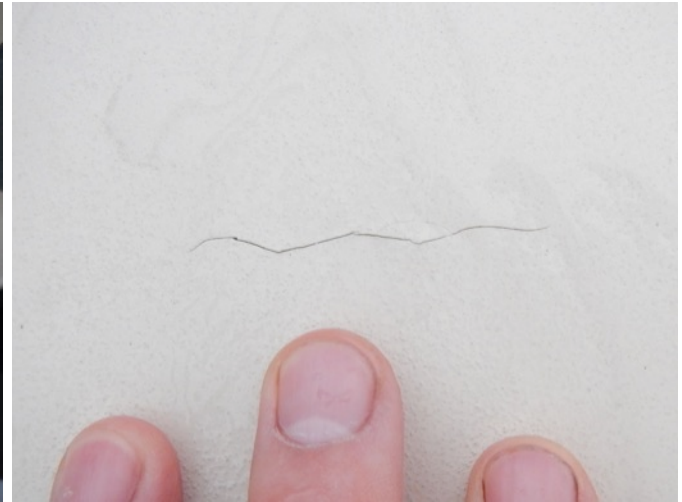
Gelcoat crack in foredeck non-skid

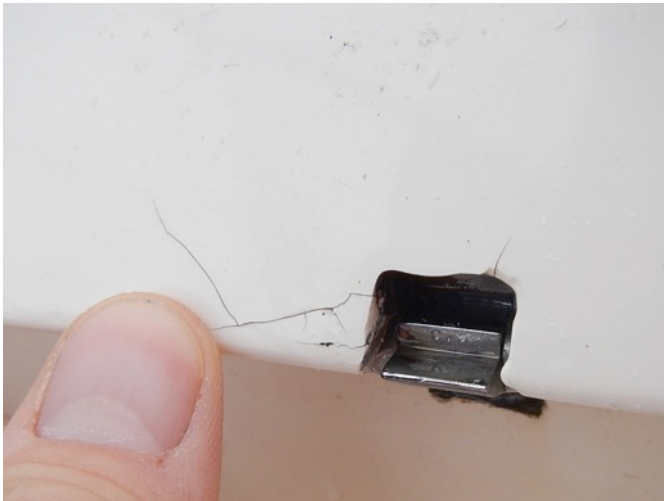
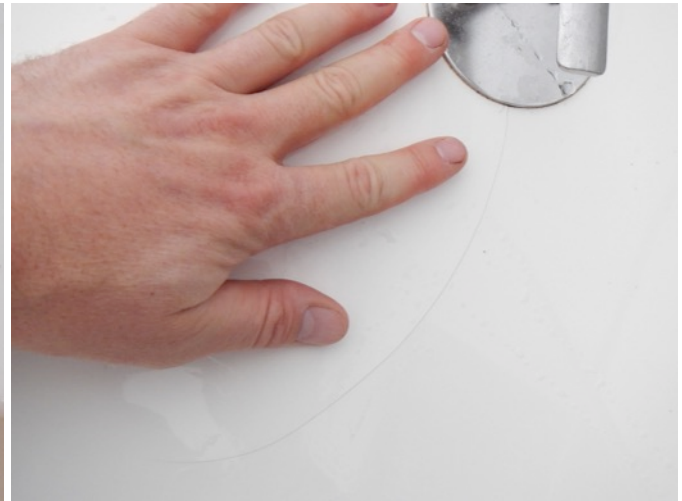
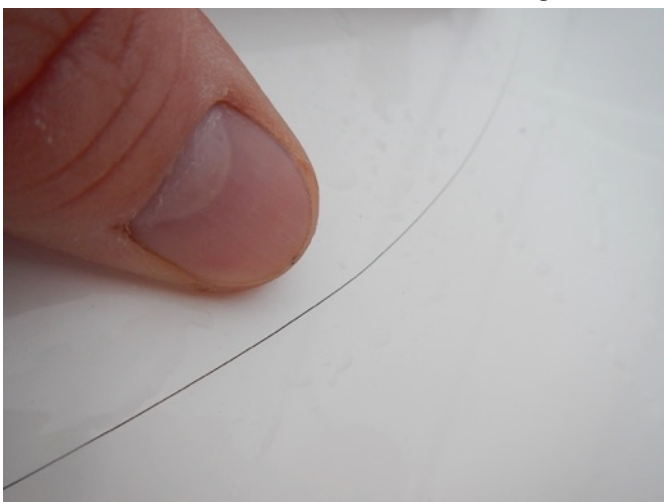
Gelcoat cracking at underside of chain locker deck hatch

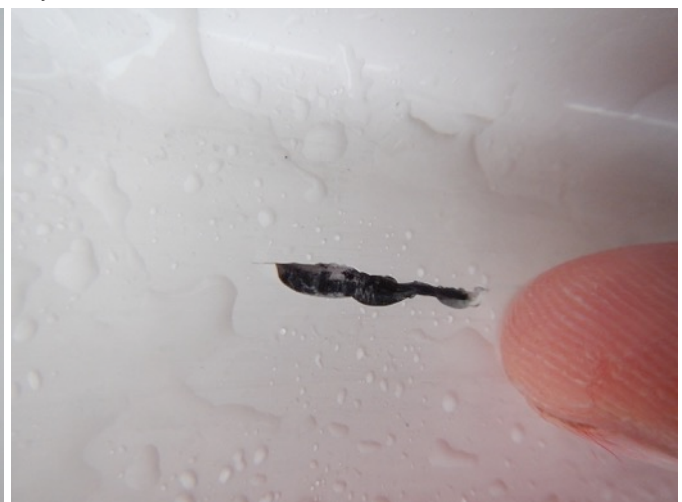
Gelcoat chip at air-bubble void

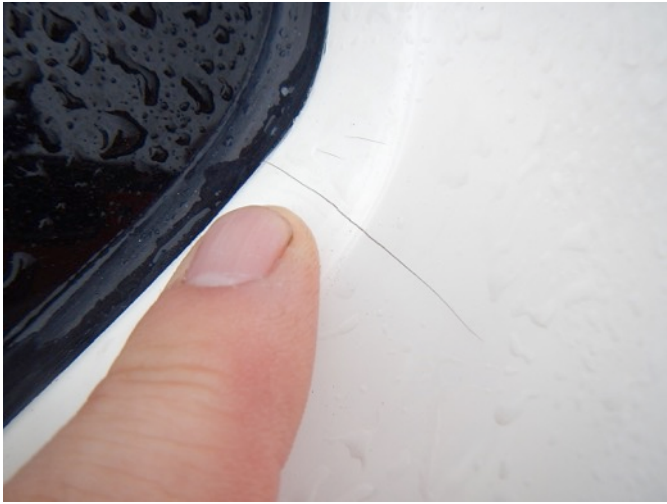
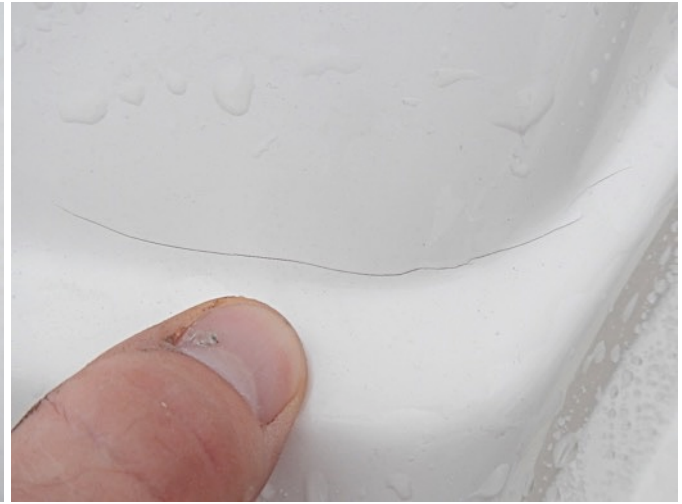
Gelcoat cracking at pilothouse windshield frame

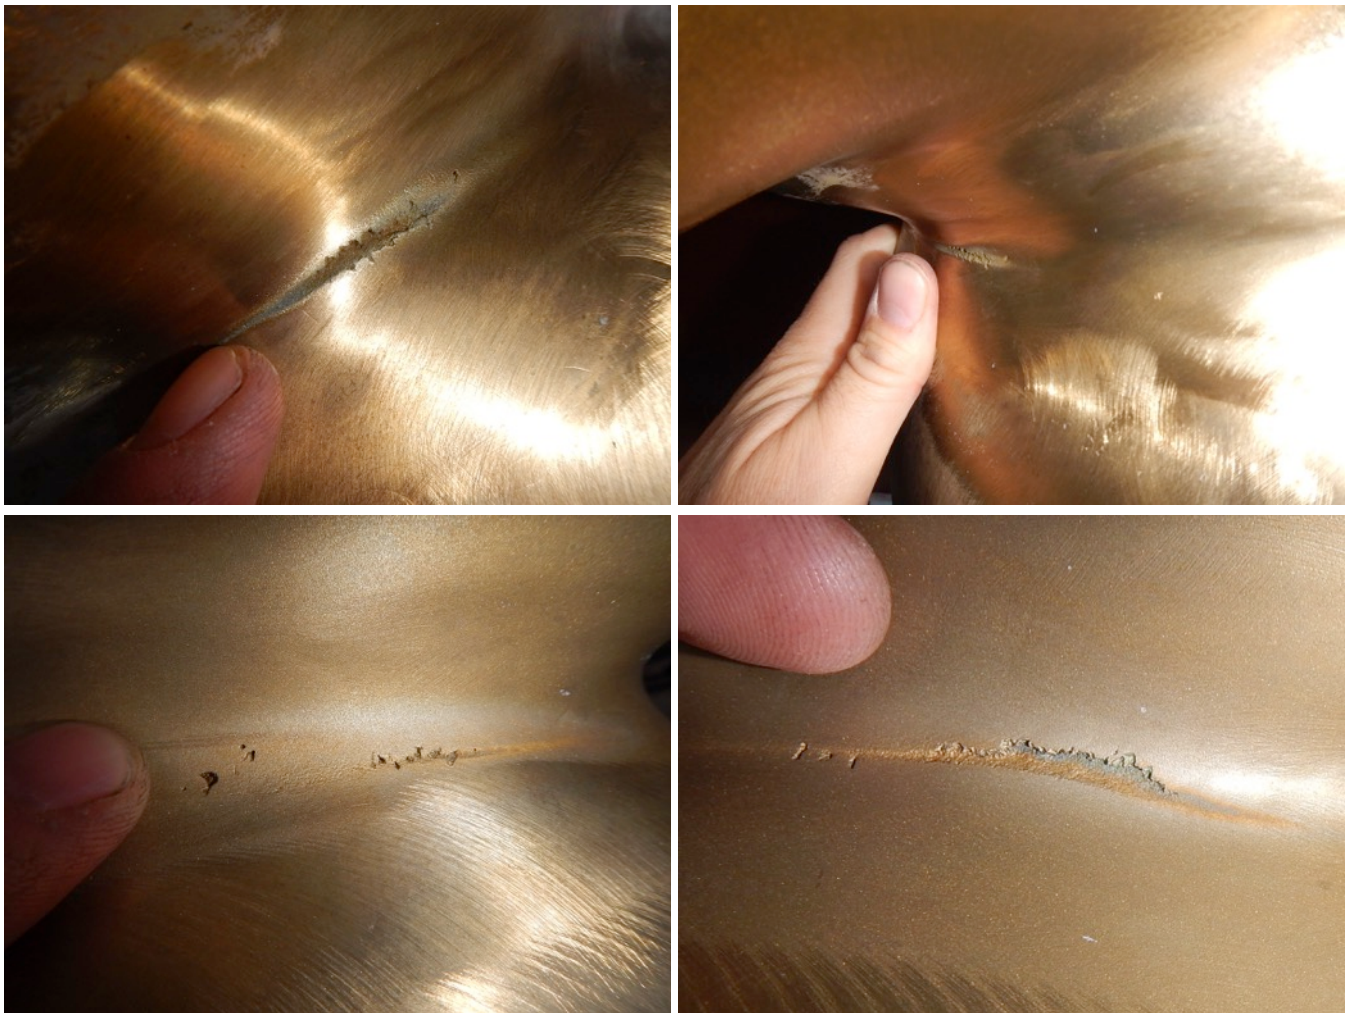
- There was minor bronze erosion identified at the vessel's props at the areas where the prop blades met the prop hubs when sighted at time of haul-out inspection. Props appear in overall structurally sound condition with no visible damage to the prop blades. Recommend monitor the condition of the vessel's props each time the vessel is hauled out of the water, and service / repair as required.

Erosion of bronze at prop hubs

2. There was minor bronze erosion identified at the vessel's props at the areas where the prop blades met the prop hubs when sighted at time of haul-out inspection. Props appear in overall structurally sound condition with no visible damage to the prop blades. Recommend monitor the condition of the vessel's props each time the vessel is hauled out of the water, and service / repair as required.

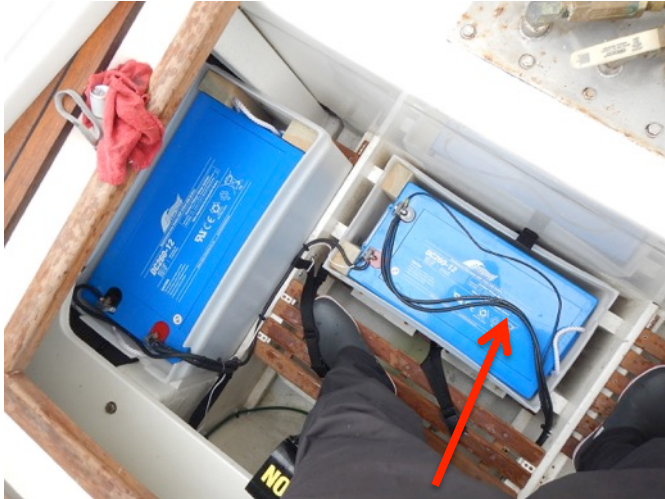
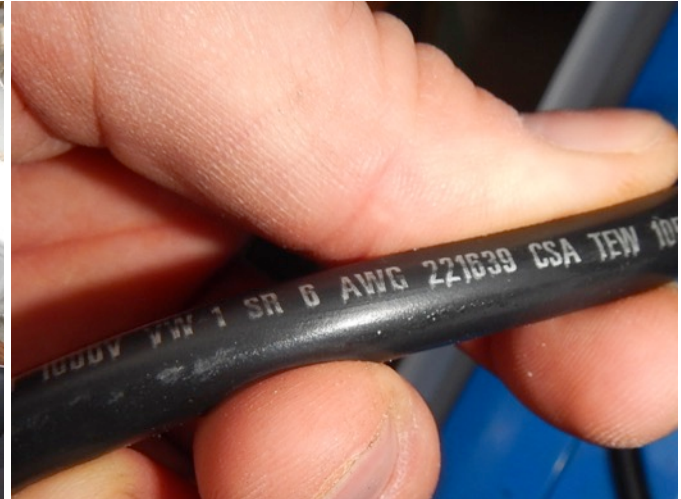
- The DC power conductors used to supply 24V DC power to the stern thruster system are size #6 AWG. Conductors described appear sized too small for the application. Recommend consult a qualified technician & refer to the stern thruster installation manual for the power conductor size recommendations. Renew power conductors described with properly sized conductors if required.

24V DC stern thruster power conductor is size #6 AWG

3. The DC power conductors used to supply 24V DC power to the stern thruster system are size #6 AWG. Conductors described appear sized too small for the application. Recommend consult a qualified technician & refer to the stern thruster installation manual for the power conductor size recommendations. Renew power conductors described with properly sized conductors if required.

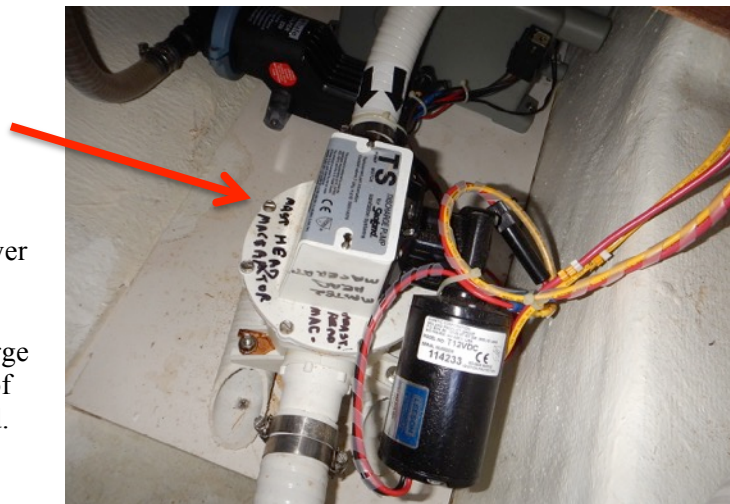
- The master-head black water tank overboard discharge pump was inoperable / would not power on when tested at time of survey inspection. The inline fuse of the DC power source to the discharge pump described was blown when inspected. The guest-head black water tank overboard discharge pump did power on when tested during survey inspection. Recommend renew the blown fuse described, and retest the master-head black water discharge pump. Service / repair or renew components of inoperable discharge pump system as required.

2. The master-head black water tank overboard discharge pump was inoperable / would not power on when tested at time of survey inspection. The inline fuse of the DC power source to the discharge pump described was blown when inspected. The guest-head black water tank overboard discharge pump did power on when tested during survey inspection. Recommend renew the blown fuse described, and retest the master-head black water discharge pump. Service / repair or renew components of inoperable discharge pump system as required.

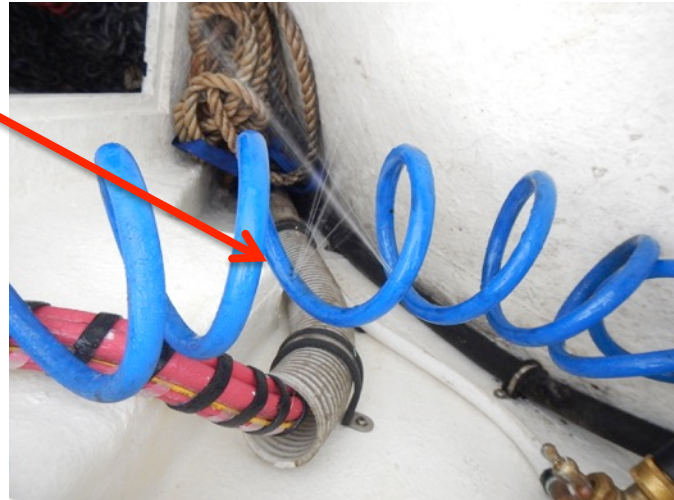
- The foredeck fresh water washdown system hose was broken & leaking when tested at time of survey inspection. Recommend renew broken washdown system hose described.

4. The foredeck fresh water washdown system hose was broken & leaking when tested at time of survey inspection. Recommend renew broken washdown system hose described.

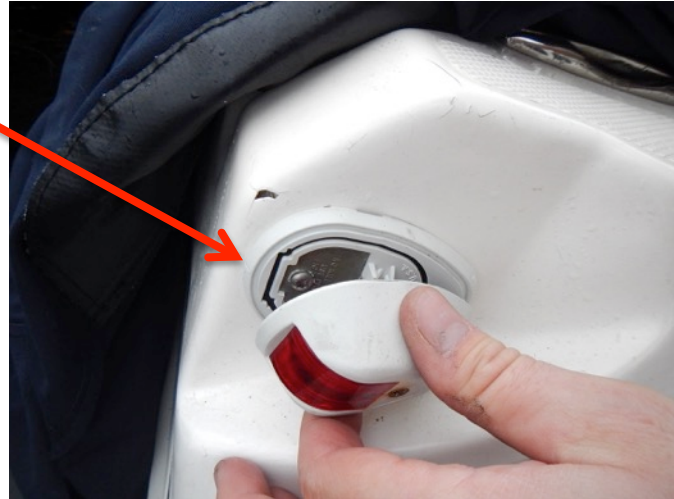
- The PORT navigation light installed on the RIB tender was inoperable & broken when tested at time of survey inspection. Recommend service / repair or renew components of inoperable tender navigation light described.

3. The PORT navigation light installed on the RIB tender was inoperable & broken when tested at time of survey inspection. Recommend service / repair or renew components of inoperable tender navigation light described.

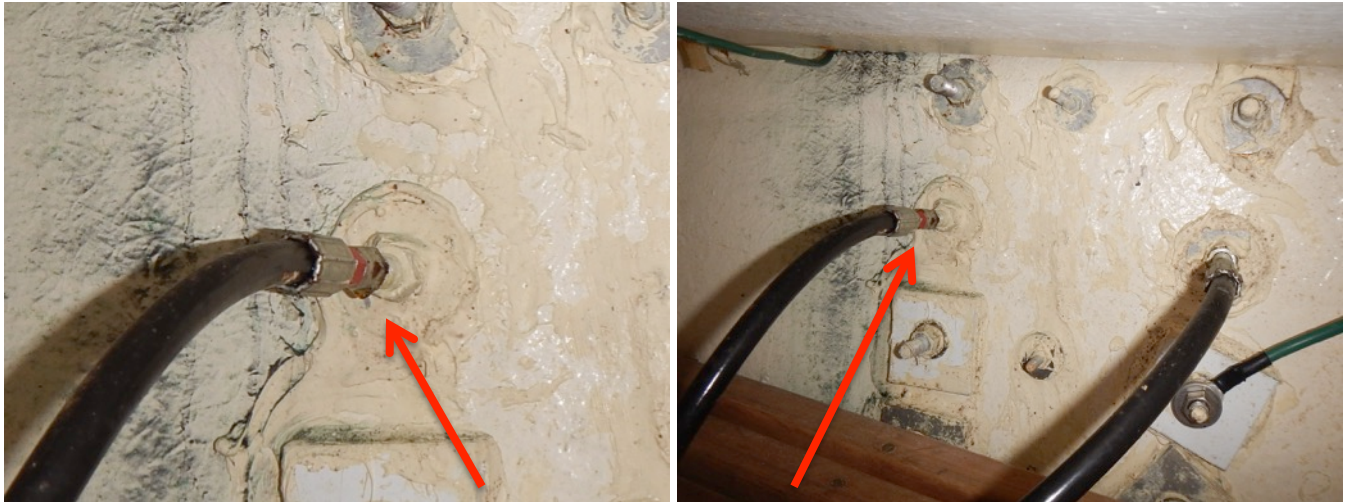
- There was a drip of hydraulic fluid identified at one of the Freedom Lift davit system hydraulic fittings that fastens to the transom structure when sighted at time of survey inspection. There was no evidence of an excessive hydraulic fluid leak, and there was no hydraulic fluid residue found in the bilge compartment below the drip described. Recommend clean hydraulic fluid drip described, and monitor davit system hydraulic line fittings for hydraulic leaks. Service / adjust or renew system components as required.

Hydraulic drip at Freedom Lift hydraulic line fitting

5. There was a drip of hydraulic fluid identified at one of the Freedom Lift davit system hydraulic fittings that fastens to the transom structure when sighted at time of survey inspection. There was no evidence of an excessive hydraulic fluid leak, and there was no hydraulic fluid residue found in the bilge compartment below the drip described. Recommend clean hydraulic fluid drip described, and monitor davit system hydraulic line fittings for hydraulic leaks. Service / adjust or renew system components as required.

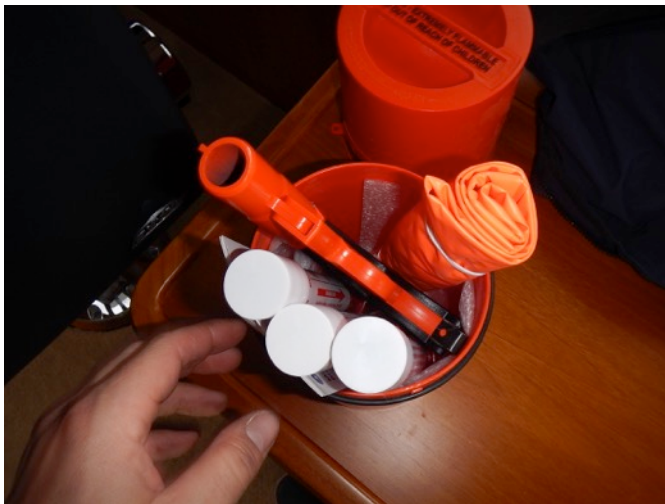
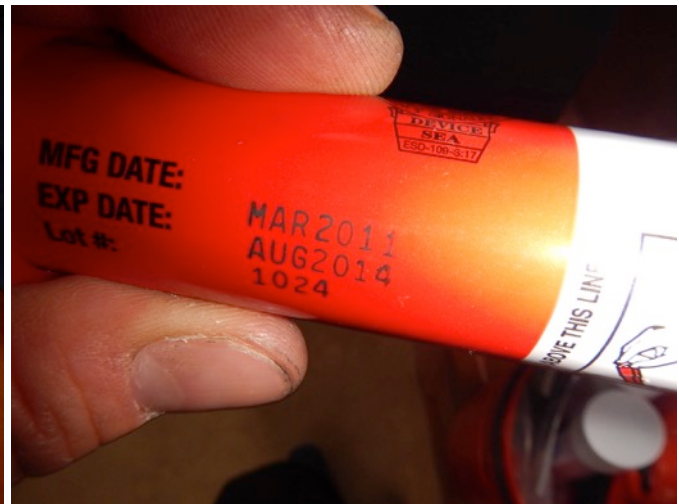
- All distress signal flares sighted onboard the vessel at time of survey inspection were EXPIRED.
USCG CFR regulations state: *All vessels 16ft. and larger are required to carry 3 distress signal flares suitable for day & night use (3 day & 3 night, or 3 rated for day or night use). (46 CFR 175.110). No person may use a boat unless each signal required by sec. 175.110 is in serviceable condition and the service life of the signal, if indicated by a date marked on the signal, has not expired. (46 CFR 175.125).*
Equip vessel in accordance with USCG CFR regulations stated above.

Distress signal flares EXPIRED

1. All distress signal flares sighted onboard the vessel at time of survey inspection were EXPIRED.
USCG CFR regulations state: *All vessels 16ft. and larger are required to carry 3 distress signal flares suitable for day & night use (3 day & 3 night, or 3 rated for day or night use). (46 CFR 175.110). No person may use a boat unless each signal required by sec. 175.110 is in serviceable condition and the service life of the signal, if indicated by a date marked on the signal, has not expired. (46 CFR 175.125).*
Equip vessel in accordance with USCG CFR regulations stated above.

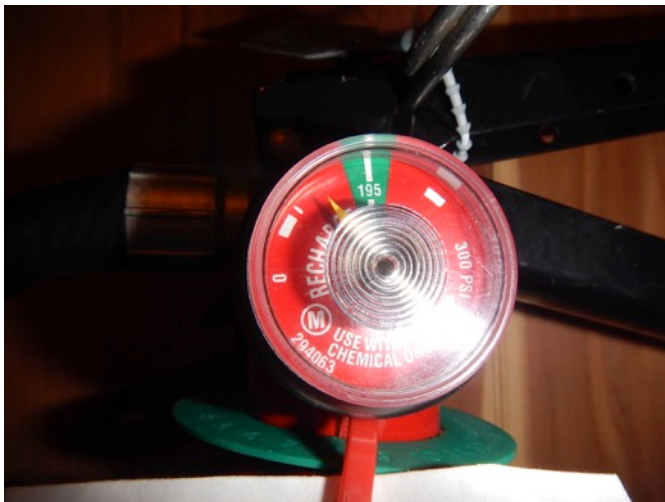
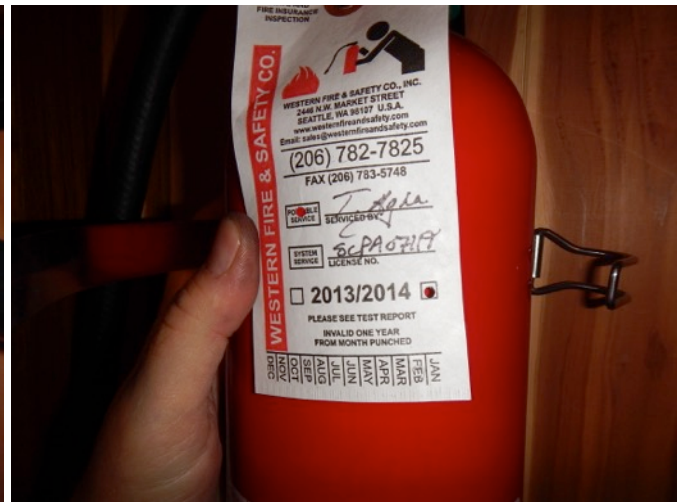
- The charge gauge of the portable fire extinguisher located at the master stateroom location pointed to RECHARGE when sighted at time of survey inspection. The inspection tags secured to all fire extinguishers found onboard the vessel indicated that inspection & service was performed in 02/2014. Recommend a qualified technician inspect and either service or renew fire extinguisher described as required.

Fire extinguisher charge gauge indicates RECHARGE

2. The charge gauge of the portable fire extinguisher located at the master stateroom location pointed to RECHARGE when sighted at time of survey inspection. The inspection tags secured to all fire extinguishers found onboard the vessel indicated that inspection & service was performed in 02/2014. Recommend a qualified technician inspect and either service or renew fire extinguisher described as required.
