REPORT OF MARINE SURVEY

CONDITION & VALUATION

1994 BAYLINER 4388 MOTORYACHT

Cale Mathers - AMS® #1156
SAMS® Accredited Marine Surveyor®

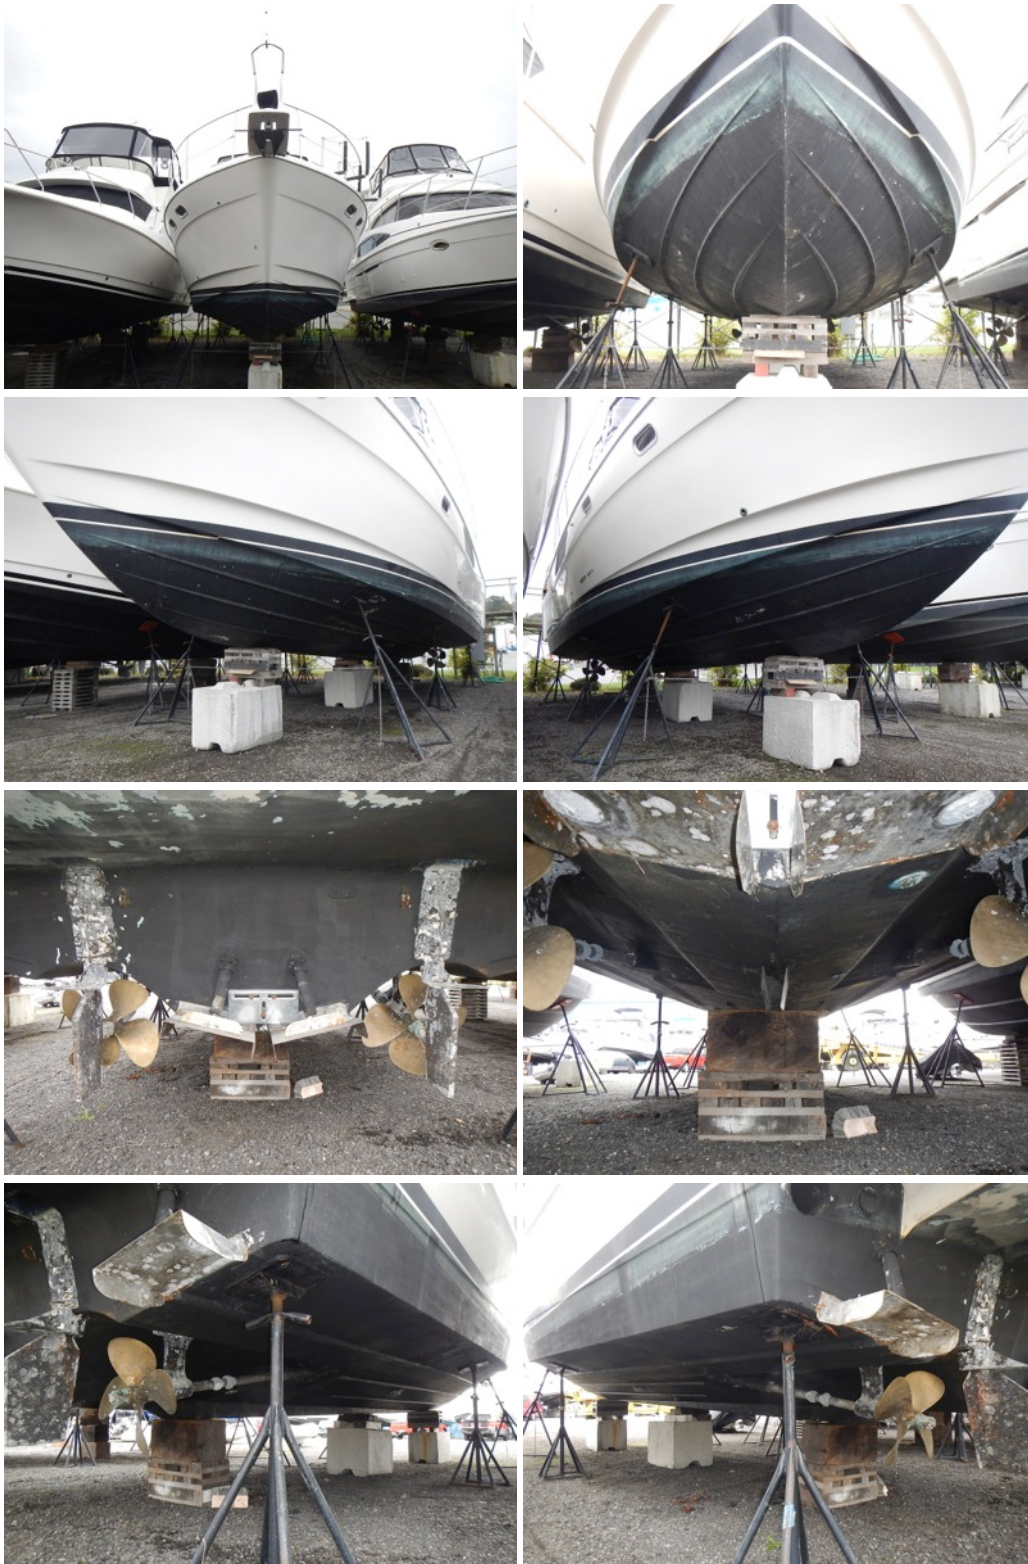
WETTED SURFACE AREA PHOTOS

Wetted surface photos taken Monday, October 13, 2014

- Vessel's anti-fouling bottom paint was peeling & deteriorating throughout the hull's wetted surface area when sighted at time of out-of-water survey inspection. The bottom paint appears in overall poor / wasted condition. Recommend service & renew vessel's anti-fouling bottom paint as required.
