REPORT OF MARINE SURVEY

CONDITION & VALUATION

2007 GRAND BANKS 49 EASTBAY SX

M/V “[REDACTED]”

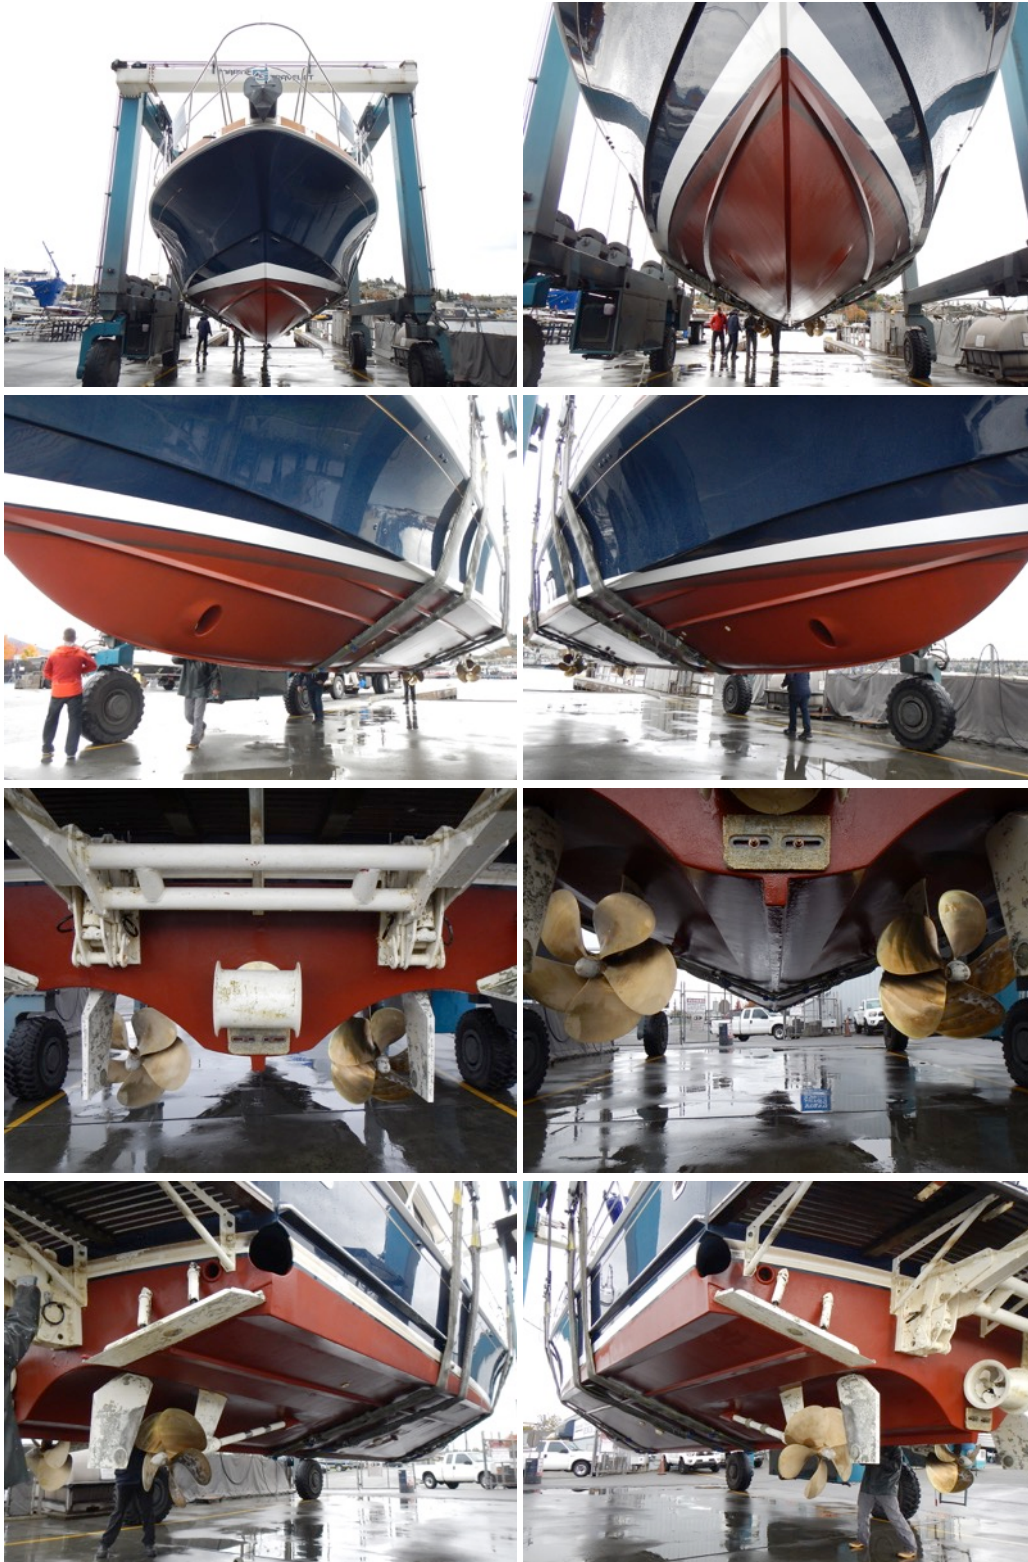
WETTED SURFACE AREA PHOTOS

Wetted surface photos taken Monday, November 3, 2014

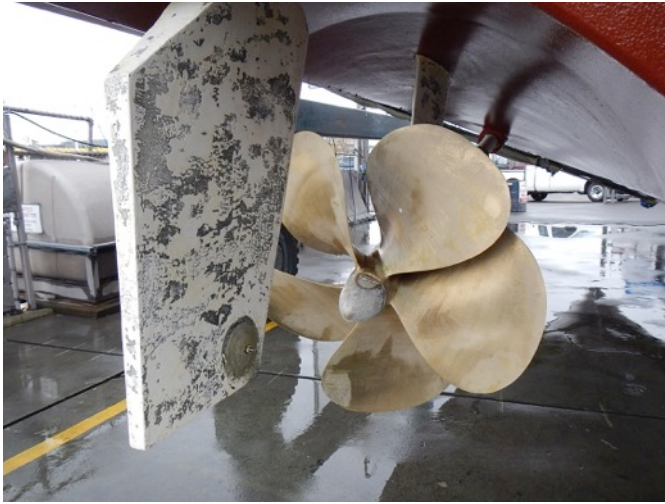
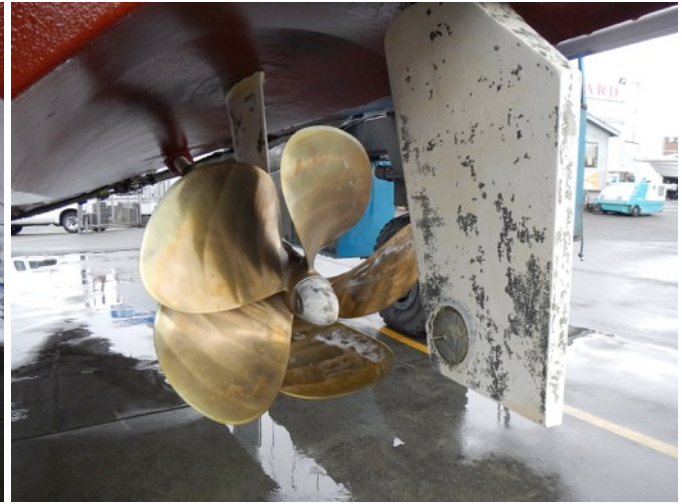
Port & Starboard Props

- There was minor bronze erosion identified at the vessel's props at the areas where the prop blades met the prop hubs when sighted at time of haul-out inspection. Props appear in overall structurally sound condition with no visible damage to the prop blades. Recommend monitor the condition of the vessel's props each time the vessel is hauled out of the water, and service / repair as required.

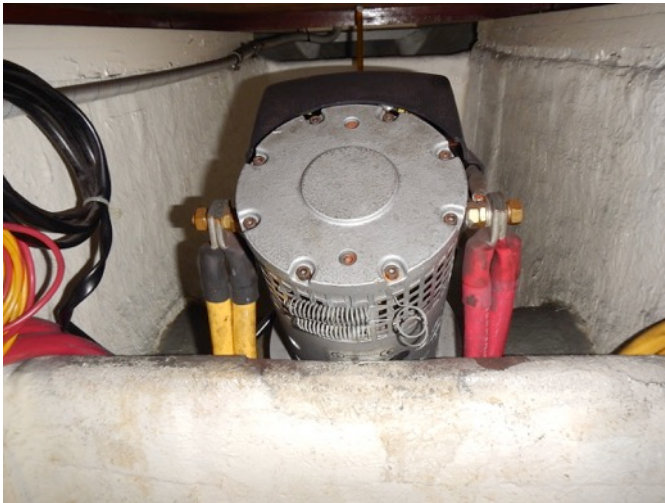
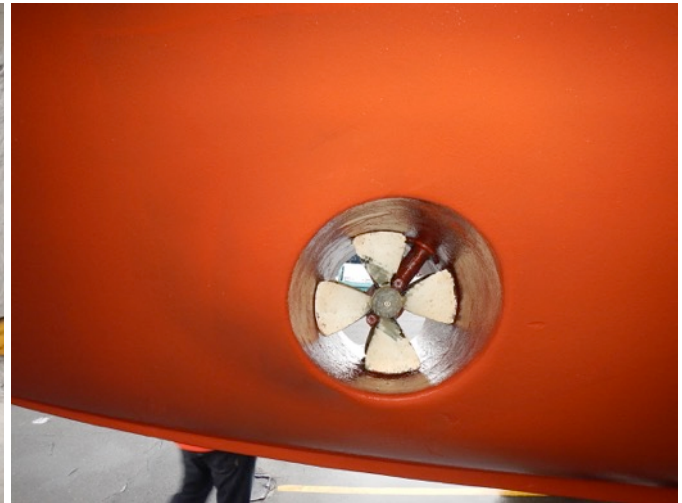
Bow Thruster

LOCATION:	Bow & Stern Thrusters
BOW THRUSTER MAKE / MODEL:	Side-Power SP 125 Ti
STERN THRUSTER MAKE / MODEL:	Side-Power SP 155 TCi
BOW THRUSTER POWER SOURCE:	12V DC
STERN THRUSTER POWER SOURCE:	24V DC
CONDITION:	Power On / Functional (All)

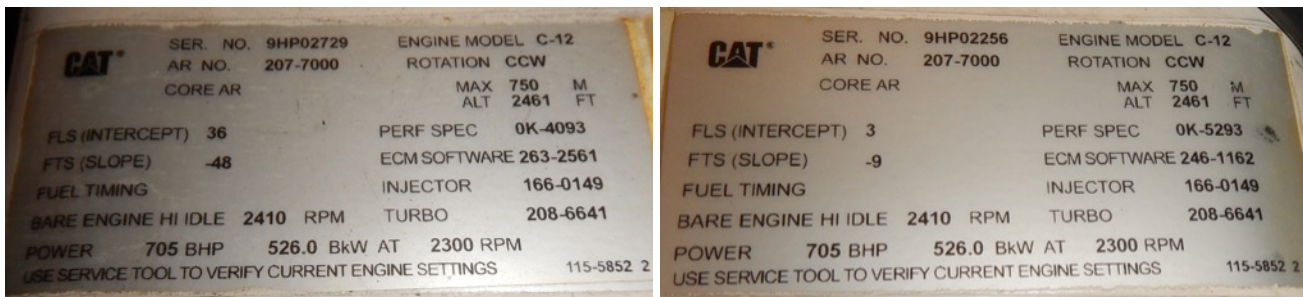
Port & Starboard Engine Labels

ENGINE QTY:	2
FUEL TYPE:	Diesel
ENGINE MAKE:	CAT / Caterpillar, Inc.
ENGINE DESCRIPTION:	6-Cylinder, Turbocharged & Aftercooled
ENGINE MODEL:	C-12 ACERT
ENGINE SERIAL:	PORT: 9HP02729 STBD: 9HP02256
RATED POWER:	705 HP @ 2300 RPM
DISPLACEMENT:	11.95 L
COOLING SYSTEM:	Fresh Water Cooled
EXHAUST SYSTEM:	Wet Exhaust
ENGINE HOURS:	PORT: 1,016 Hrs. (Indicated by Digital Gauge) STBD: 1,016 Hrs. (Indicated by Digital Gauge)

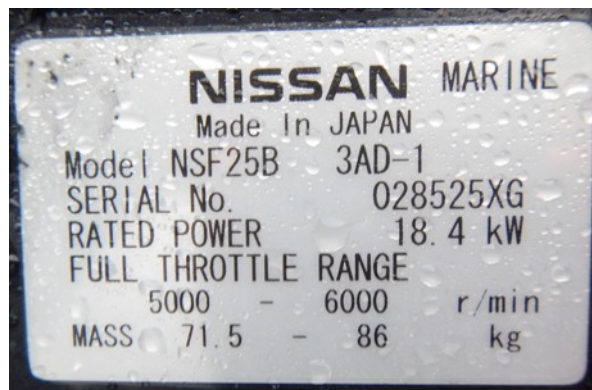
Outboard Engine Label

MAKE / MODEL:	Nissan
DESCRIPTION:	Outboard Motor
MODEL:	NSF25B 3AD-1
SERIAL:	028525XG
RATED POWER:	25 HP
CONDITION:	Appears Good / Started During Inspection
